LOCAL VESSELS ADVISORY COMMITTEE

Discussion of the Collision of a Vessel towards the Kap Shui Mun Bridge on 23.10.2015

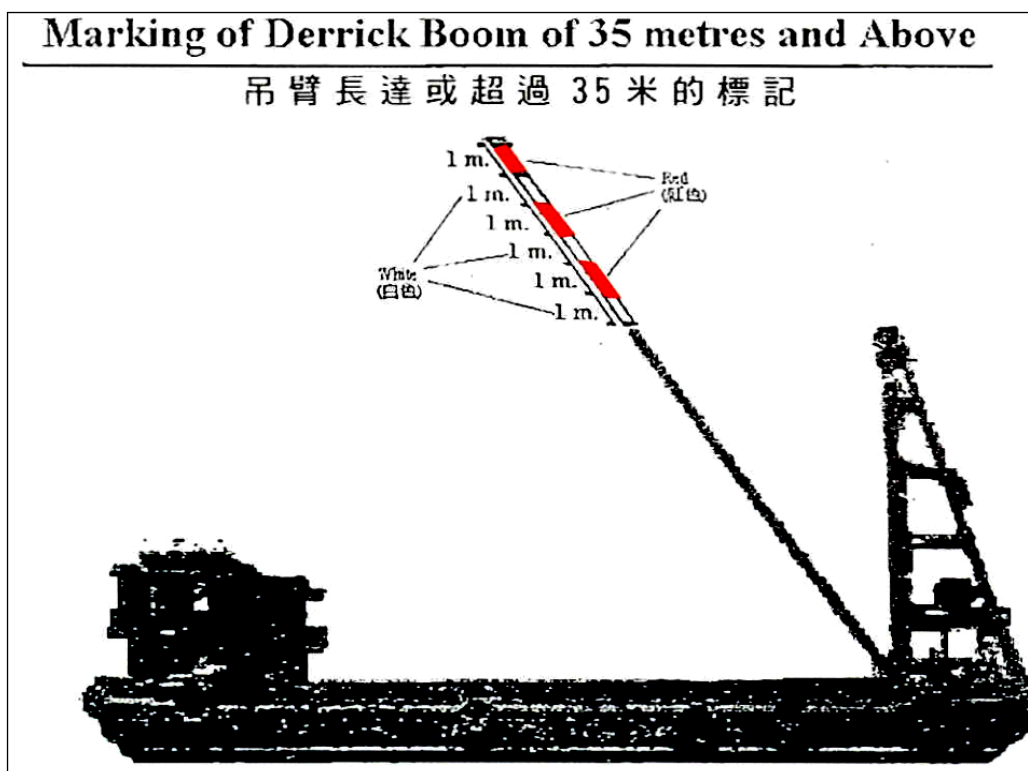
6. Moreover, the height of lifting appliances of some local vessels using the Kap Shui Mun Fairway might have exceeded the said limit. To ensure the integrity of KSMB and promote a better understanding of the above legislation in the industry, a licence condition to prohibit vessels with a crane or derrick boom length of 35 metres or more from entering the height restricted area of KSMB has been imposed forthwith on the licence of the vessels since 1 June 1998¹. In addition, alternate red and white strips are required to be marked on the crane or derrick boom that is 35 metres or higher for the purpose of easy identification by the patrol vessels of MD (see *the diagram*² below).
