Report on the Investigation of the Collision between
M.T. SANCHI
and
M.V. CF CRYSTAL
in East China Sea
on 6 January 2018

Very Serious Marine Casualty
10 May 2018

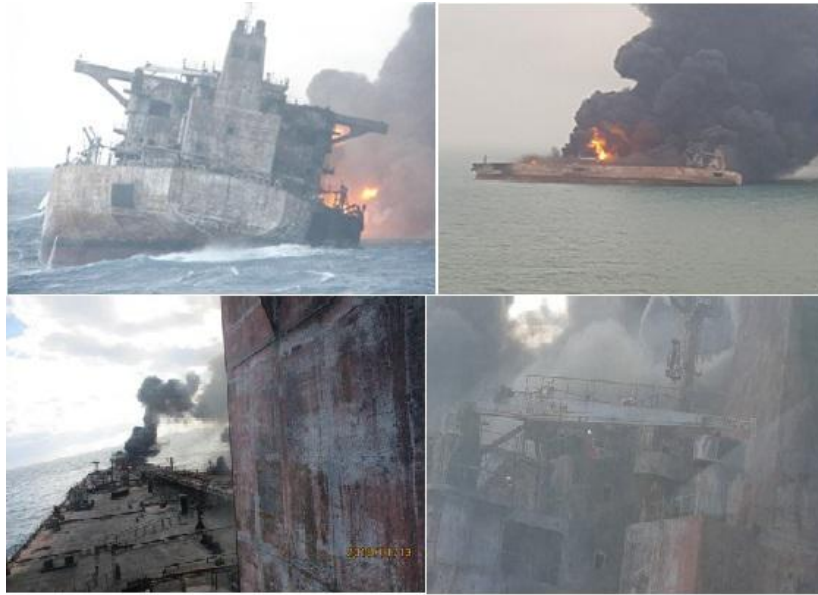
Figure 3- Photos taken on the spot

From 0835LT to 0905LT on 13 January 2018, 4 rescuers were sent on board SANCHI in a basket from SHENQIAN. At that time, the spilled oil on the sea surface was still burning on the starboard side of the SANCHI and the smoke was rather heavy with high temperature. (Figure3/4)

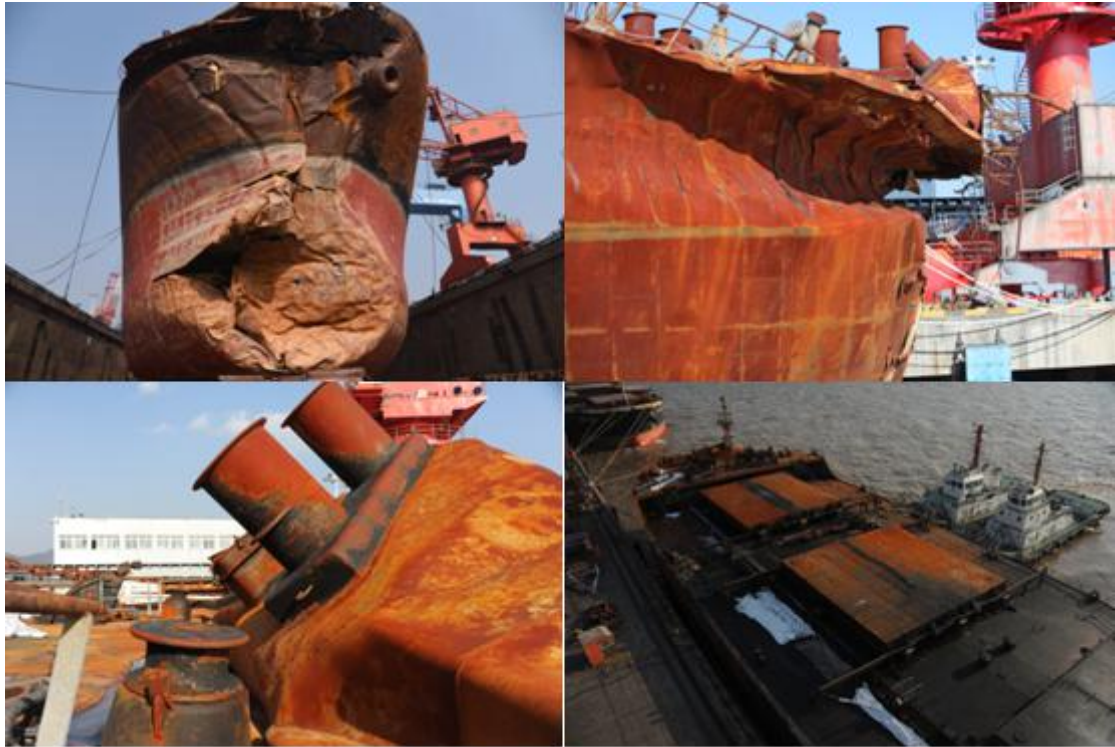
Figure 5-Damage Inspection of CF CRYSTAL

The whole bulbous bow had plunged backward into the hull, and the impacting surface was slightly to the right; the anchor chain storage in the front end of the bow presented a "V" shape, the sag on the starboard side bow was slightly larger than the port side, both of two bow anchors were lost; the bulwark of forecastle deck concaved towards the starboard, the sag was slightly curved and the depression was located above the forecastle deck. The forecastle deck was severely distorted and deformed; ship's storeroom and forepeak were struck through; heavy deformation had occurred on main deck from the bow to NO.3 cargo hold. (Figure 5)

The main deck between the bow and No.3 cargo hold sustained fire causing damage to the windlasses, mooring winches, the front mast and the firefighting box; the whole ship's port side sustained fire damage, and the lifeboat on the port side was damaged. For the starboard side, the parts from the bow to the front of No.3 cargo hold were also burnt. (See Annex F - CF CRYSTAL Survey Report)

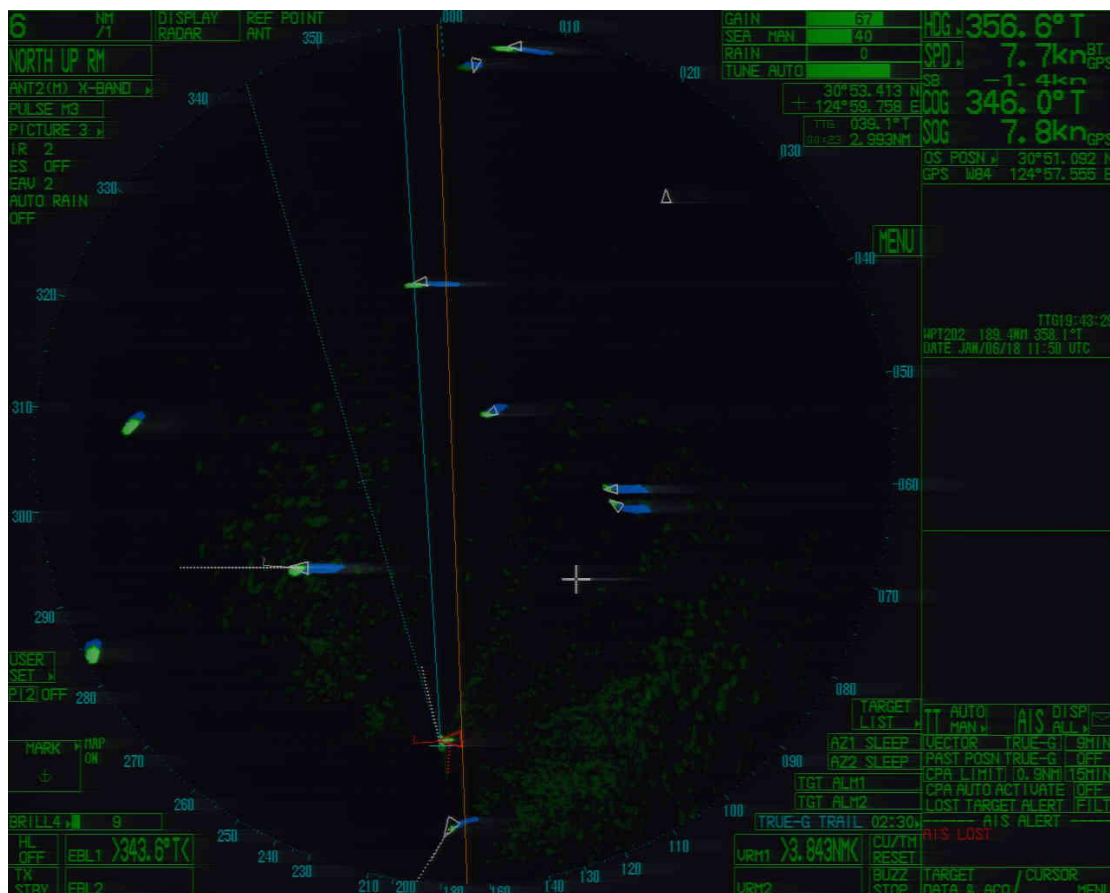
Figure 7- SANCHI's X Band Radar Display at 1951LT (right after collision)

The VDR of SANCHI recorded the sound of collision and deflagration, as well as the voice of duty crew in bridge at 1950 LT, which reflected the dramatic emotional changes. The image of X-Band Radar extracted from the VDR (one capture every 15 seconds) showed that the heading changed from 358° at 1949 LT to 338° at 1951LT(Figure 7), meanwhile, the vessel speed

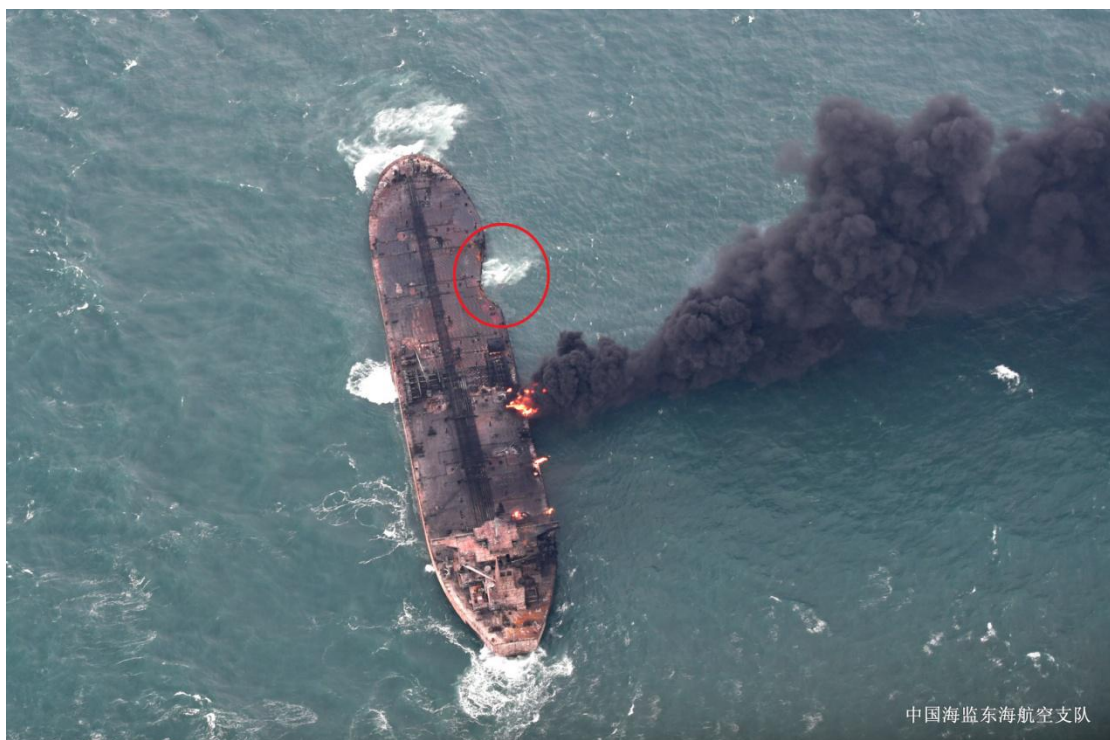
Figure 8-Arial Picture taken on 10 January

The bow of CF CRYSTAL collided with the starboard side hull between No.2 and No.3 ballast tanks, breaching the boundary of the No.2 and No. 3 starboard cargo tanks of SANCHI. When the collision occurred, CF CRYSTAL was heading 226°, and SANCHI 358°. So the angle of blow between the two ships was about 48°. This was consistent with the damage inspection of both vessels. (Figure 8)

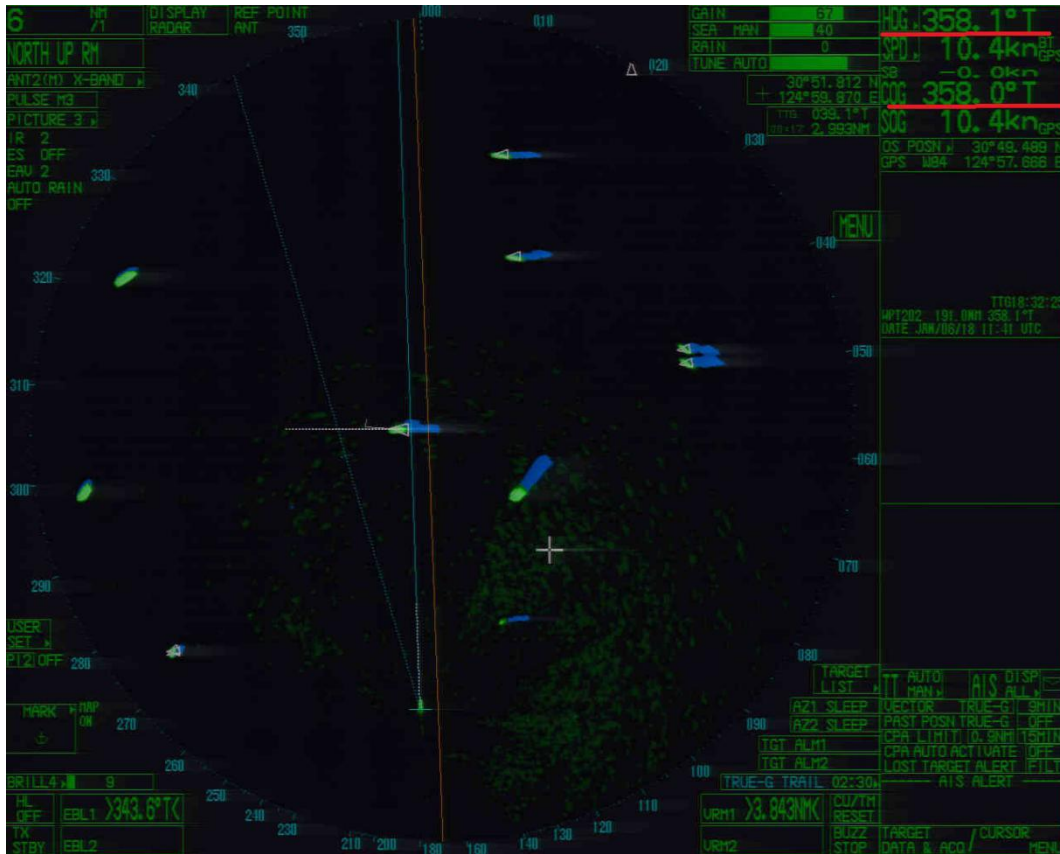
Figure 9 SANCHI's X Band Radar Display at 1941LT

It was found that partial dynamic data of SANCHI and CF CRYSTAL such as heading, position obtained from SANCHI's VDR and two passby vessels' VDR was consistent. However, there were 20 to 25 degrees differences of COG and 2 to 3 kts differences of SOG between the SANCHI's AIS information received by other vessels and the readout of SANCHI's VDR. (Table 9/10, Figure 9)

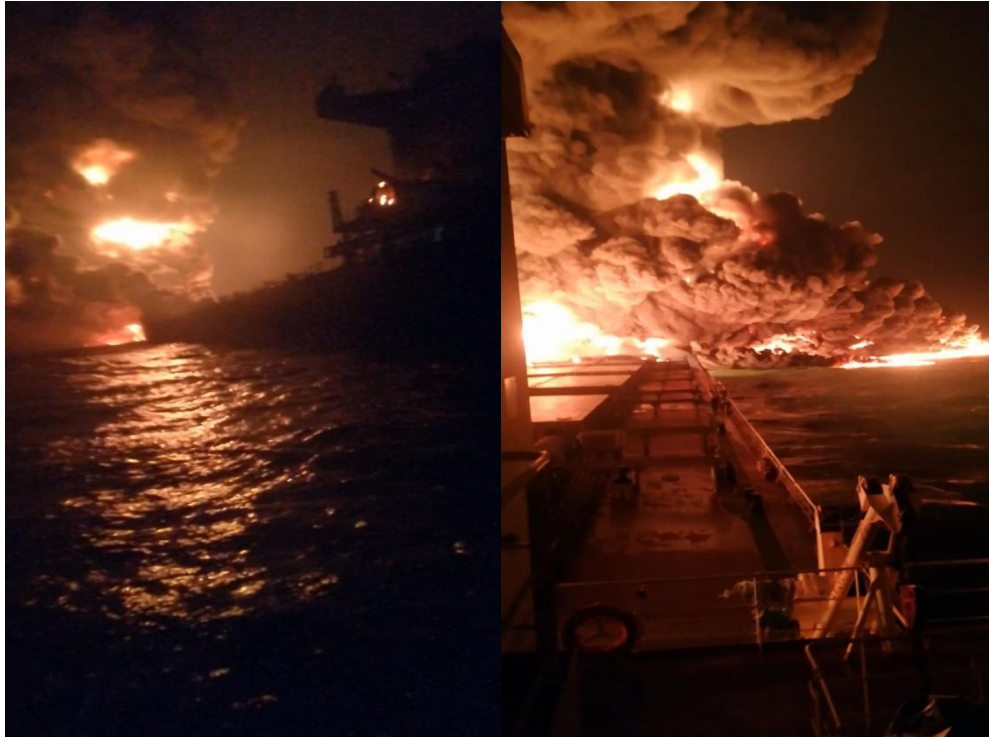
Fire and Explosion after Collision

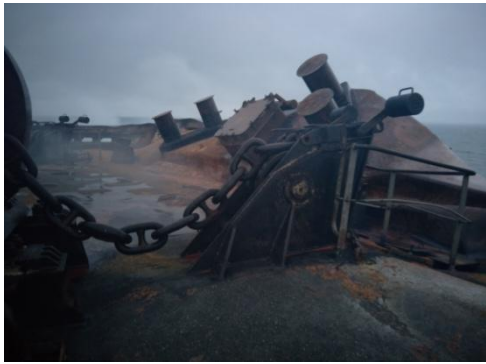
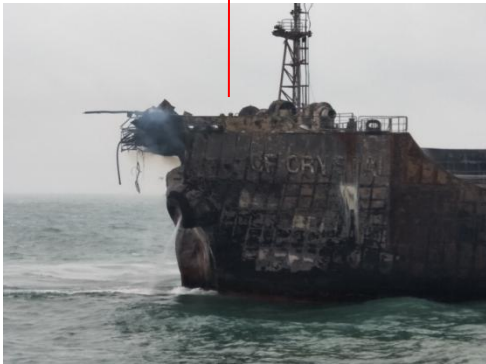
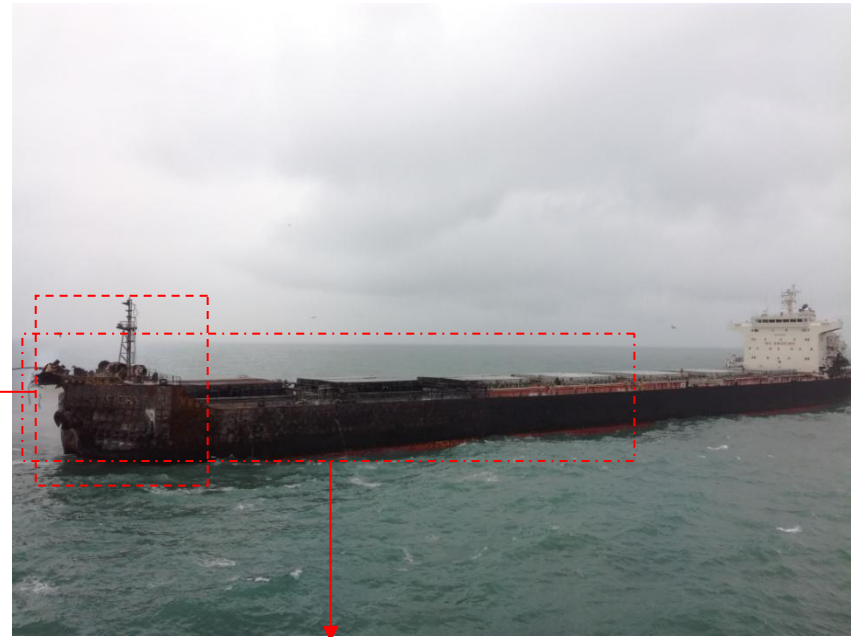
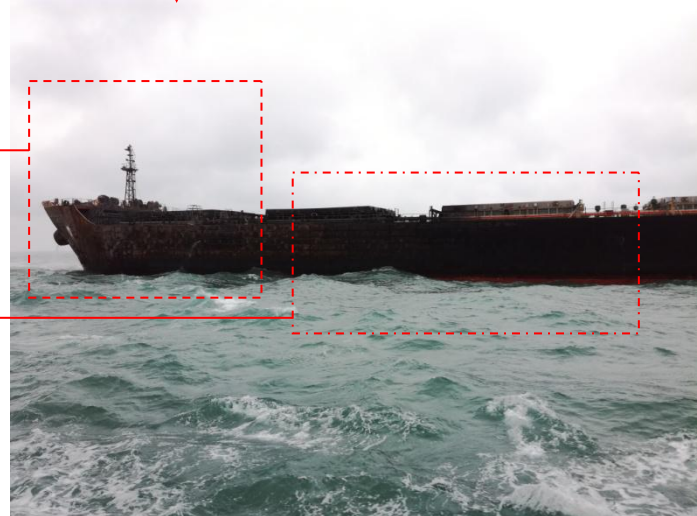
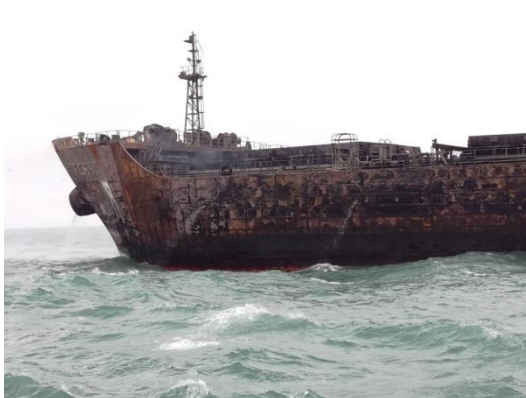
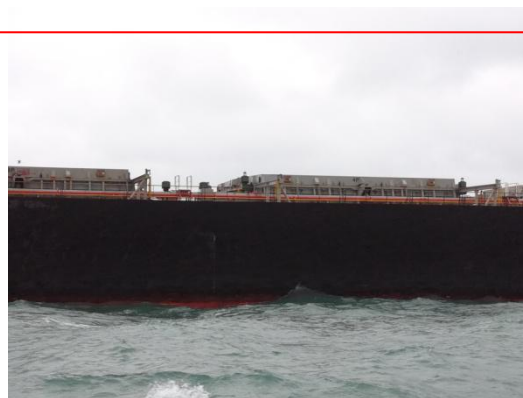
The damage to the bow of CF CRYSTAL and color difference between bow and midship
