MARINE DEPARTMENT NOTICE NO. 90 OF 2008

Safe Working Practices for Fishing Vessels **in Pair Trawling Operation**

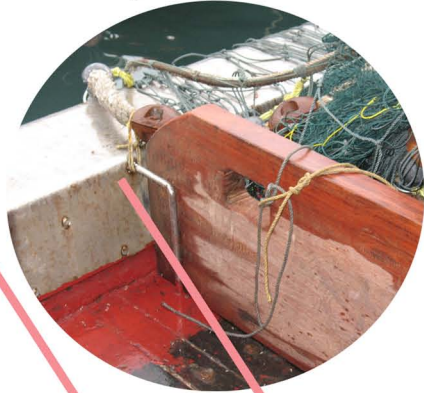
The weld of starboard aft steel seating was cracked

- i) all trawling gears and deck fittings should be maintained in good working order;
- ii) only proper permanent mooring fixture, e.g. permanent D-ring, should be used to secure similar stopper in a pair trawling preparation; and
- iii) personal protective gears, e.g. safety helmet, should be worn in such operations.

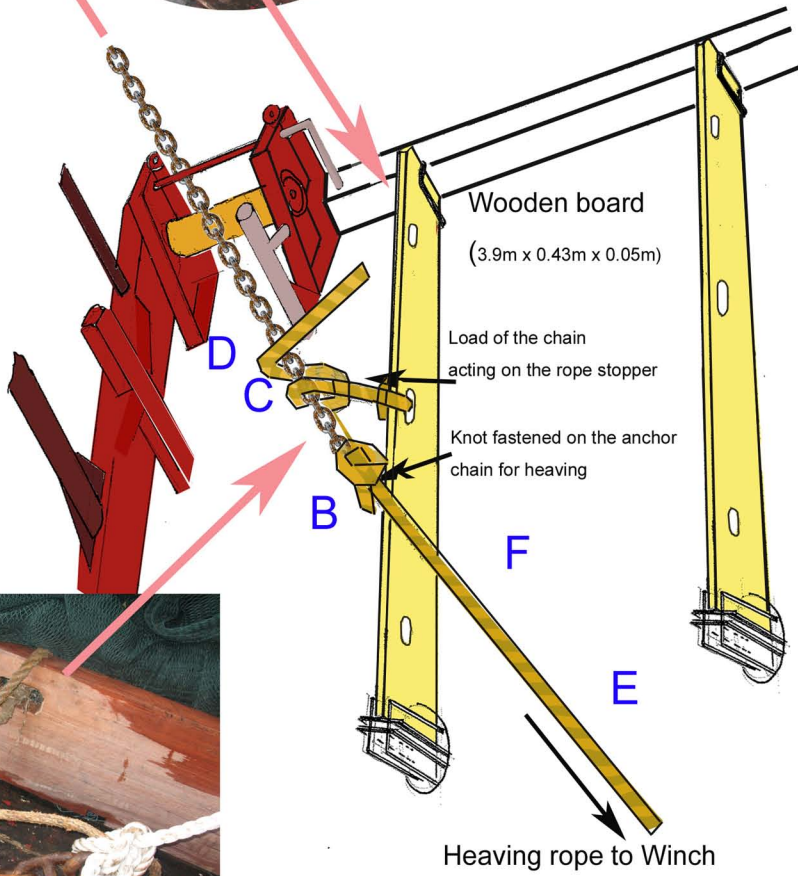
Starboard Stern Section
of the fishing vessel

Anchor Chain
to partner vessel
for paired trawling

The letters coloured in blue
are the locations of fishmen during the incident

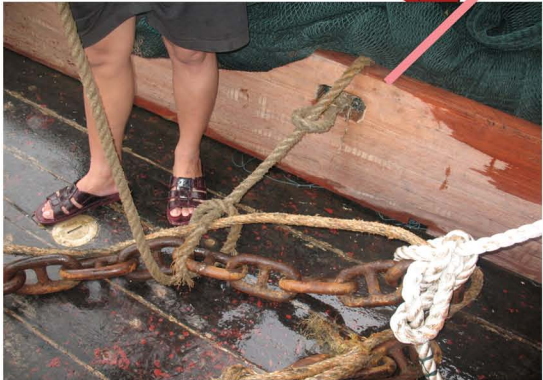
On 5 August 2007, six fishermen on board a fishing vessel were preparing to launch fishing nets to sea for pair trawling in the South China Sea. While they tried to transfer the load of an anchor chain to a rope stopper attaching to a wooden board on deck, the board slipped out from its seating, hit and killed one of the fishermen.

The similar wooden board causing the fatal accident
