Report on the Investigation of the Collision between
M.T. SANCHI
and
M.V. CF CRYSTAL
in East China Sea
on 6 January 2018

Very Serious Marine Casualty
10 May 2018

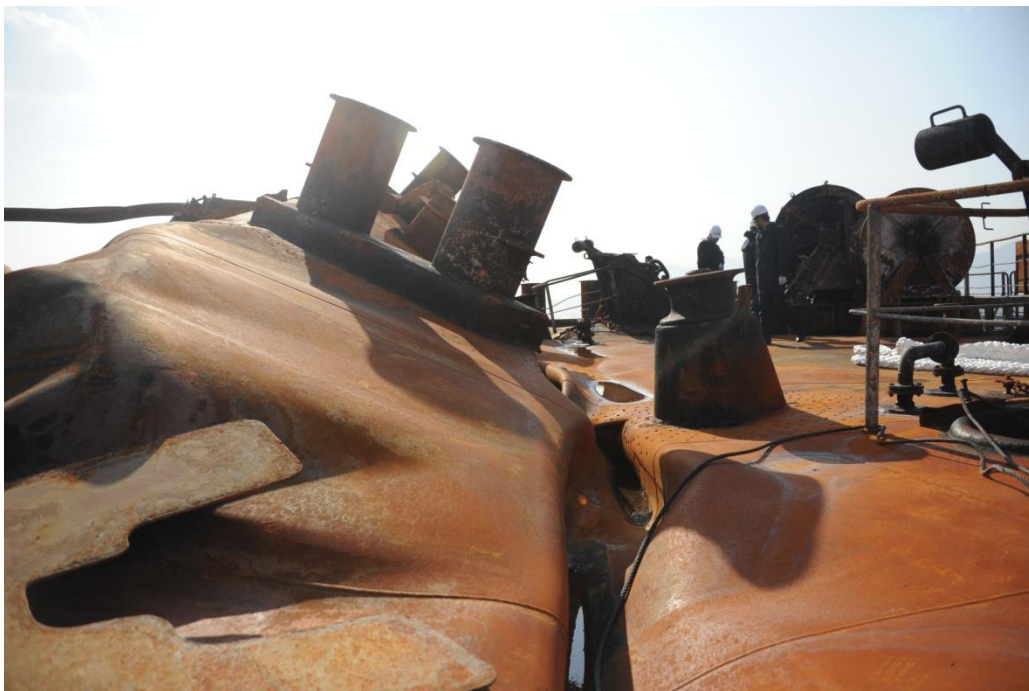
Forecastle deck bending backwards

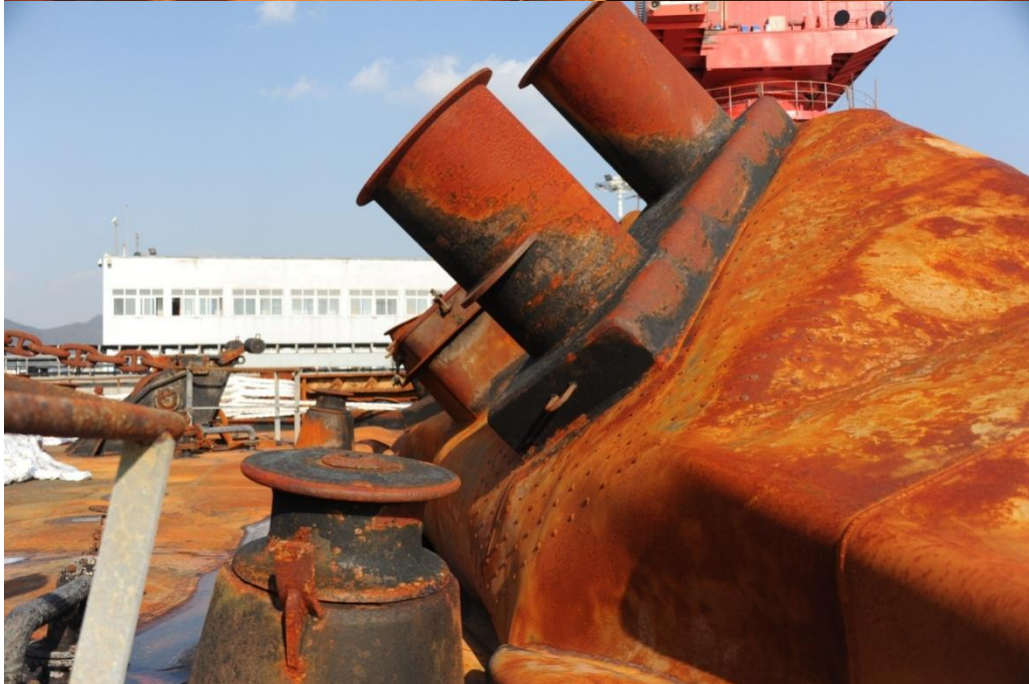
Fore-castle deck bending backwards

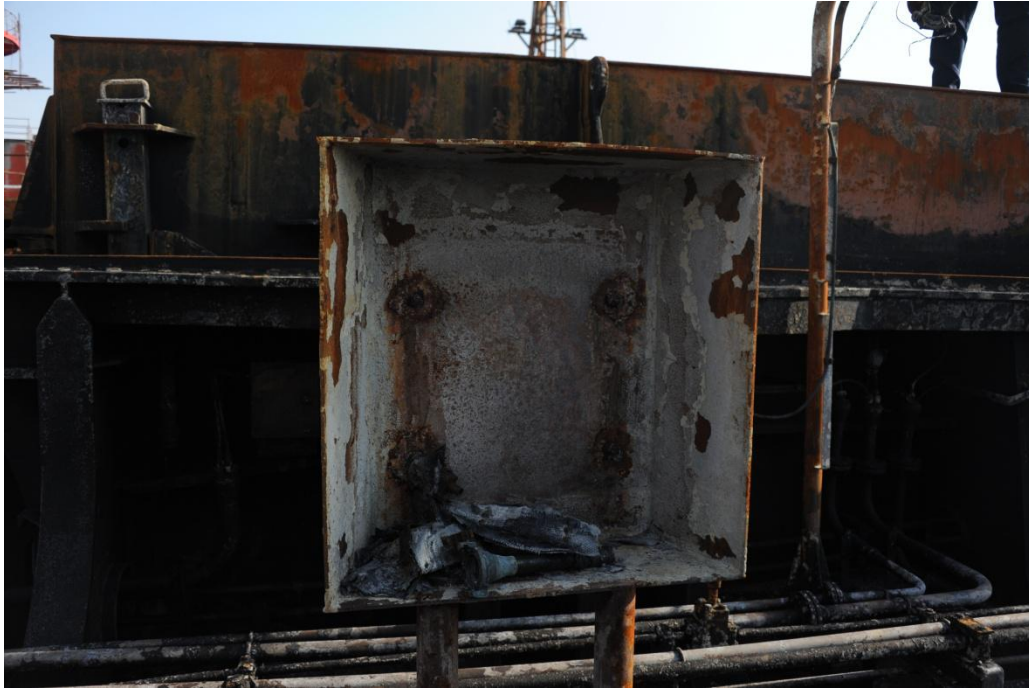
Fire Box Debris

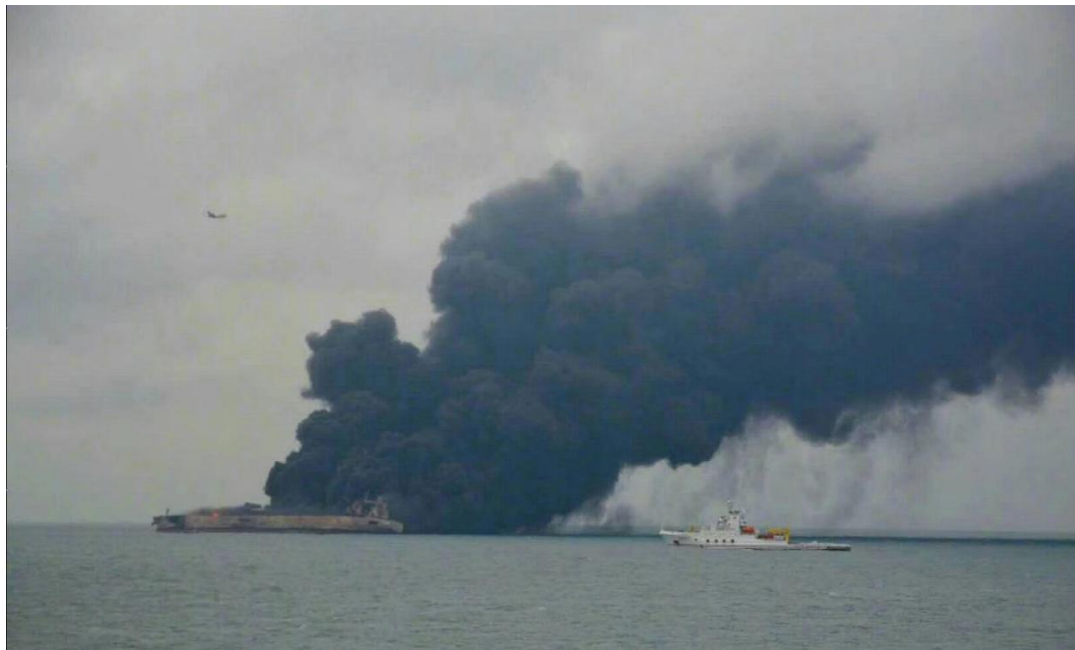
SANCHI on Fire and Vessel listing to Starboard

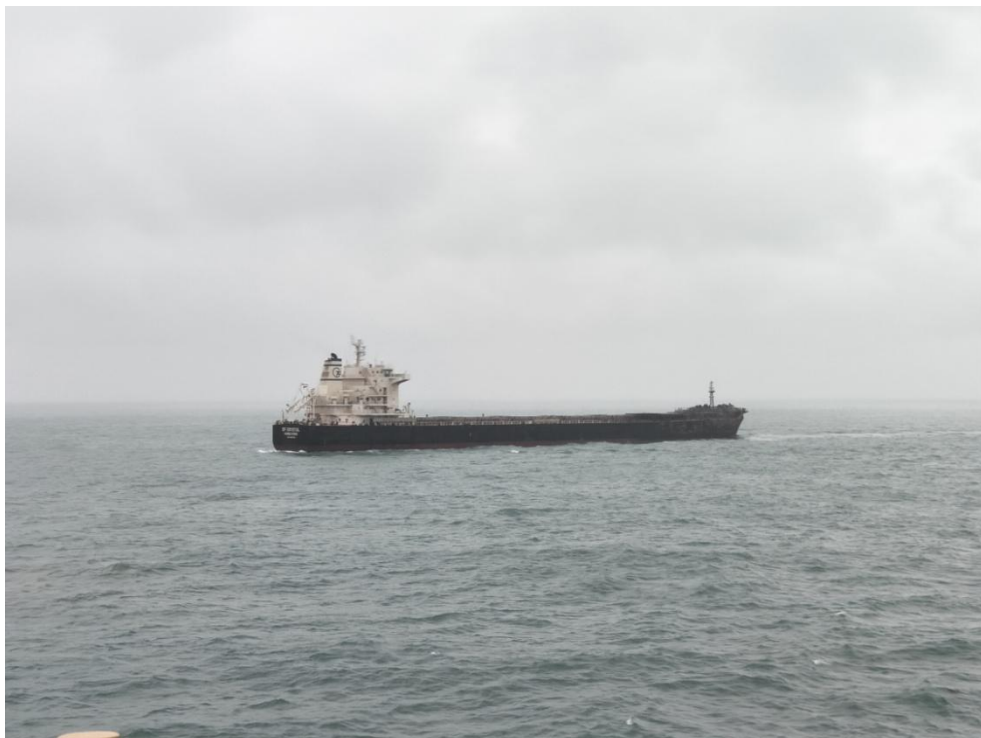
Starboard Quarter View

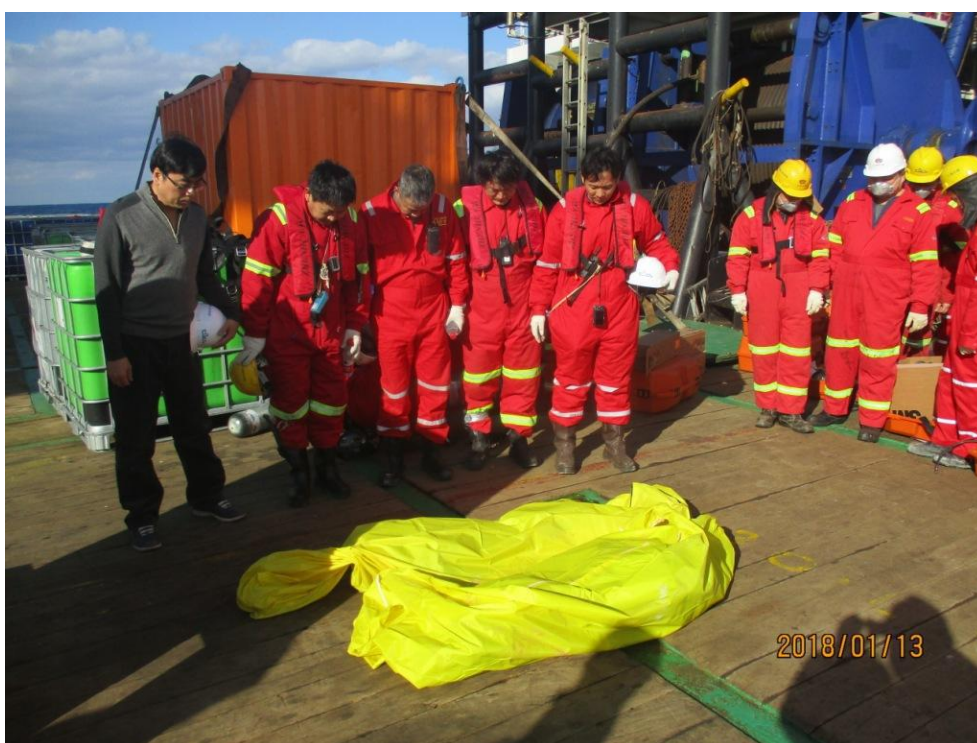
SAR personnel found the bodies of two crew members on boat deck ,
retrieved VDR capsule from the bridge.
