**High Speed Craft Consultative Committee (HSCCC)**

**Proposed Changes of Navigation Aids for Marking Adamasta Rock**

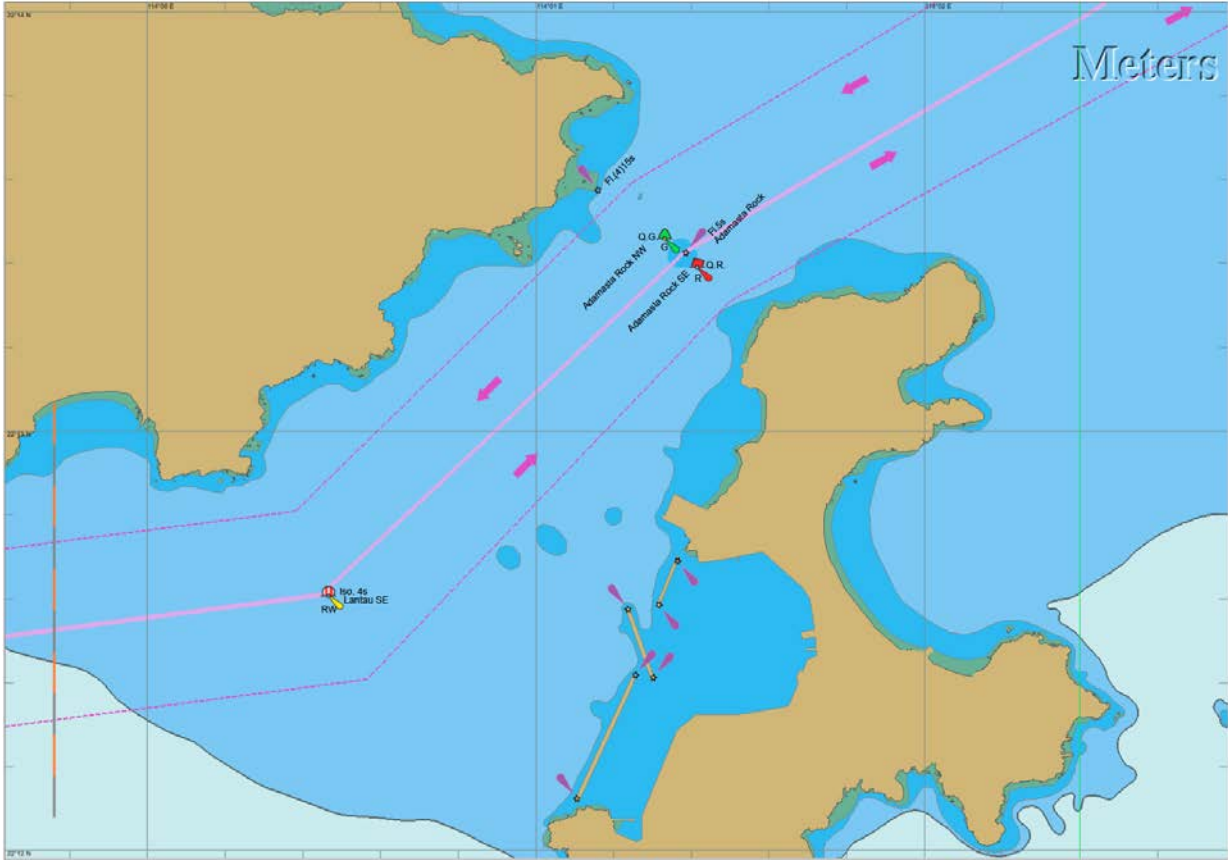
northwest of Adamasta Rock shoal; the red can shape buoy laid at the southeast of Adamasta Rock shoal; and the light beacon erected at Adamasta Rock. These navigational aids and the traffic lanes in the vicinity of Adamasta Rock are shown in Diagram 1 below.

**Diagram 1: Navigational aids and traffic lanes in the vicinity of Adamasta Rock**

3. An internal review on the existing navigational aids was conducted for identifying improvements to navigational safety around Adamasta Rock. It is noted that the green conical shape buoy and the red can shape buoy are presented as a pair of lateral buoys laid at the extremities of the Adamasta Rock shoal of about 200 metres apart. As there is a perception that a pair of lateral marks, i.e. the green and red buoys, are laid to mark the two

sides of a waterway, mariners who are not familiar with the Conventional Direction of Buoyage at the Adamasta Channel may consider to travel between the two buoys, in case that they are also not aware of the existence / meaning of the light beacon at Adamasta Rock.

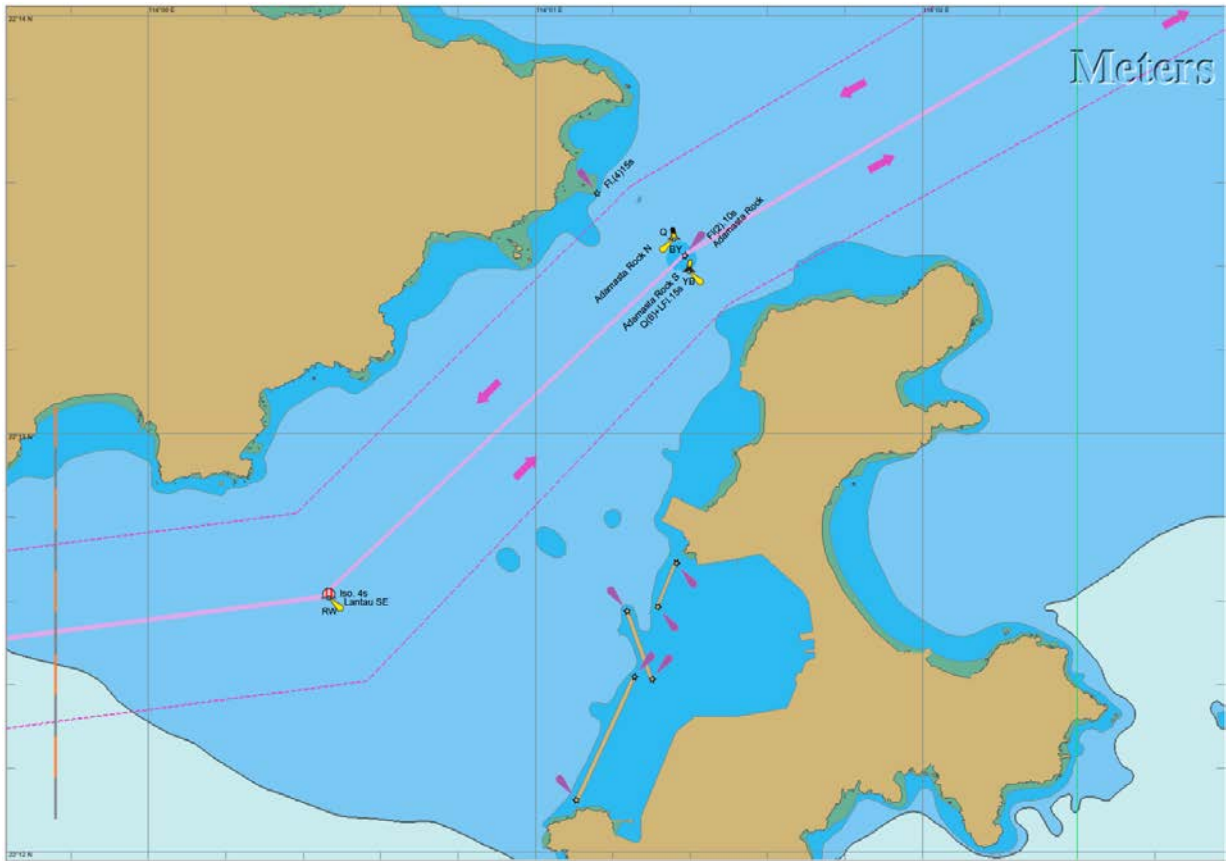
5. Taking consideration of the above findings, the review proposed to replace the existing two lateral buoys by two cardinal buoys<sup>2</sup> at nearby locations, i.e. a cardinal buoy with northern top mark at position of Latitude 22° 13.47' North, Longitude 114° 01.36' East (in WGS 84 Datum) and a cardinal buoy with southern top mark at position of Latitude 22° 13.38' North, Longitude 114° 01.39' East (in WGS 84 Datum), where are the northern and southern extremities of the Adamasta Rock shoal. The light characters of the proposed northern and southern cardinal buoys are "Quick-flashing" and "Quick-flashing (6) followed by a long-flash" respectively. Given the distance between these two buoys is about 200 metres apart, it is also proposed to indicate more clearly the isolated danger characteristic of the beacon at Adamasta Rock by changing the light character of the beacon to "Group-flashing (2)", and painting the beacon with black and red horizontal bands. The proposed navigational aids for marking Adamasta rock are shown in Diagram 2 below.

**Diagram 2 : Proposed Navigational Aids for Marking Adamasta Rock**

6. Upon conducting navigation simulations by utilizing the full mission ship simulator in the Marine Department's Training Centre, it is evaluated and concluded that the above proposal is a better option for guiding vessels navigating in the vicinity of Adamasta Rock.
