Report on the Investigation of the Collision between
M.T. SANCHI
and
M.V. CF CRYSTAL
in East China Sea
on 6 January 2018

Very Serious Marine Casualty
10 May 2018

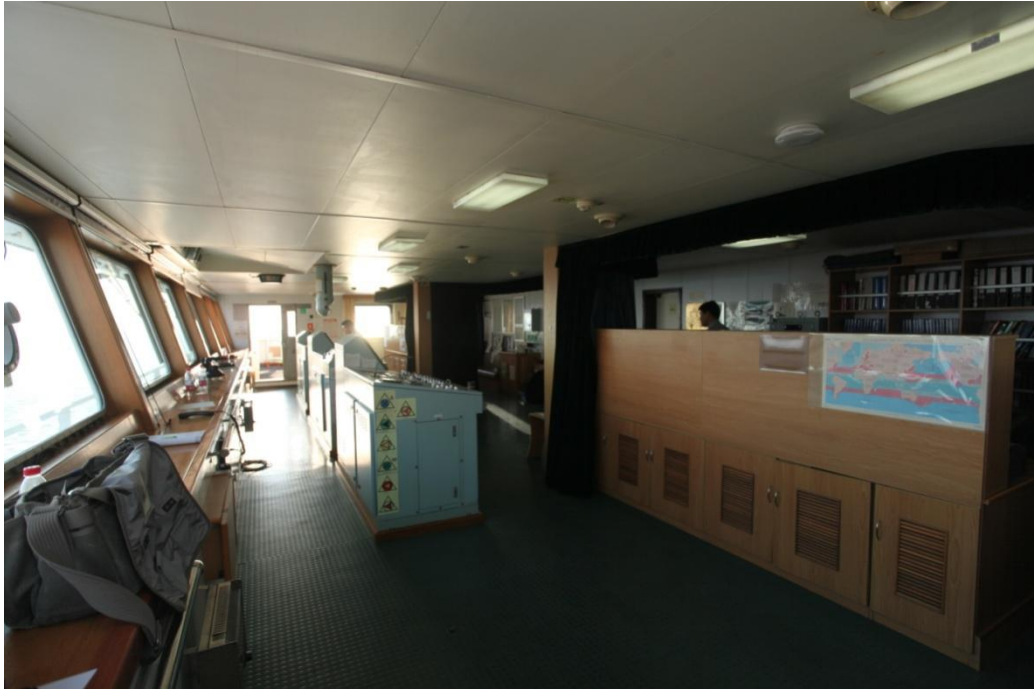
Figure 6-The Bridge of CF CRYSTAL

Navigational equipment: 2 sets of radar with types of FURUNO FAR-2827 and FURUNO FAR-2837S; 1 set of AIS with the type of FURUNO FA-150; 1 set of GPS with the type of FURUNO GP-150; 1 set of Meteorological Fax Receiver with the type of FURUNO FAX-408; 1 set of Navtex Receiver with the type of FURUNO NX-700; Voyage Data Recorder, FURUNOVR-3000; 3 sets of VHF, FURUNO FM-8800S. The ECDIS was not equipped on board.(Figure 6)

According to on-site inspection, the main and auxiliary engine, steering gear, radio equipment and navigational devices of the vessel worked in a normal condition.

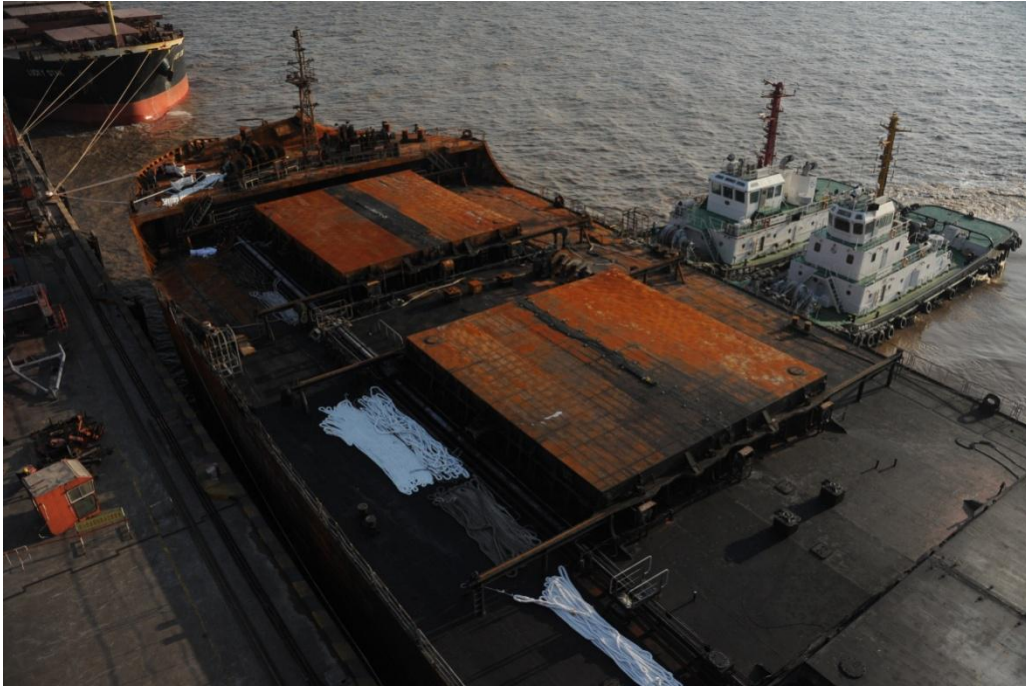
Top View from Midship Forward (forward No.3 cargo holds sustained fire)

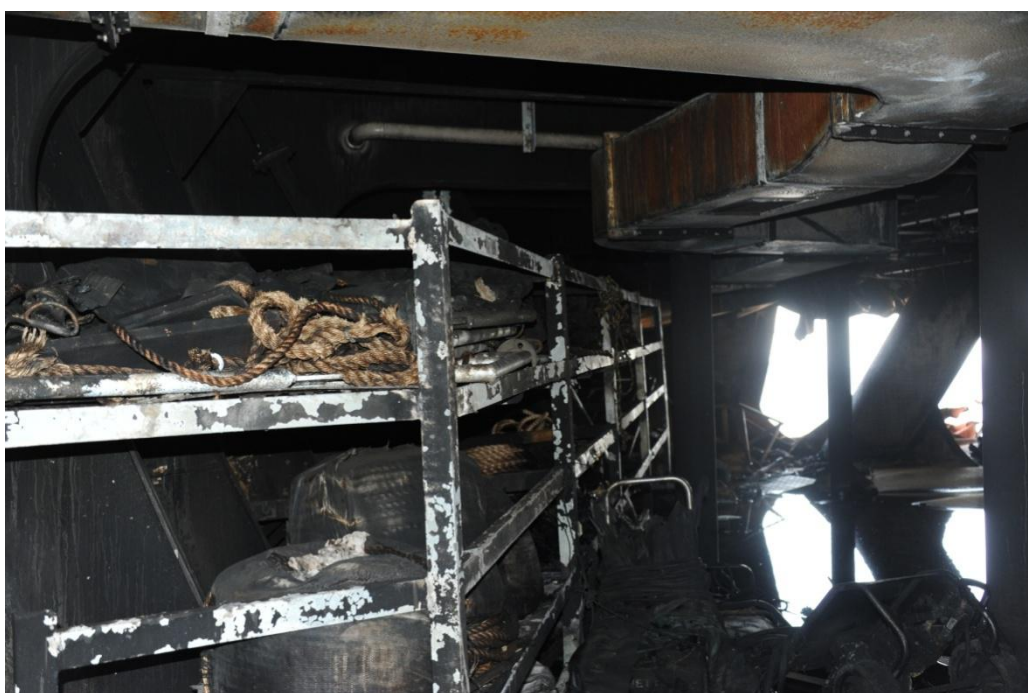
Inside Port Side Store

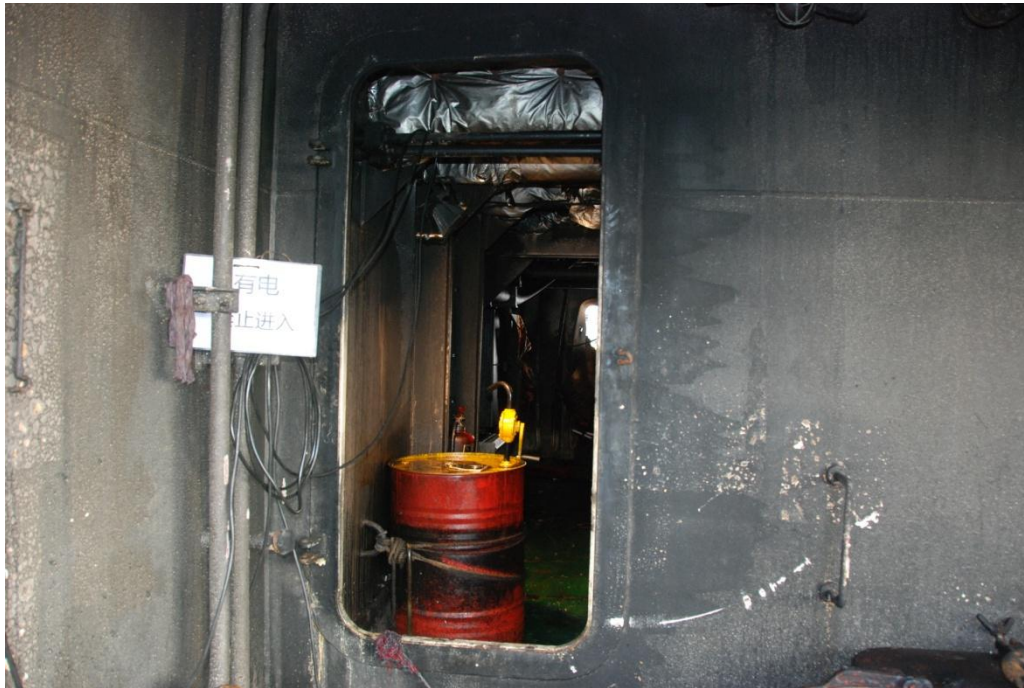
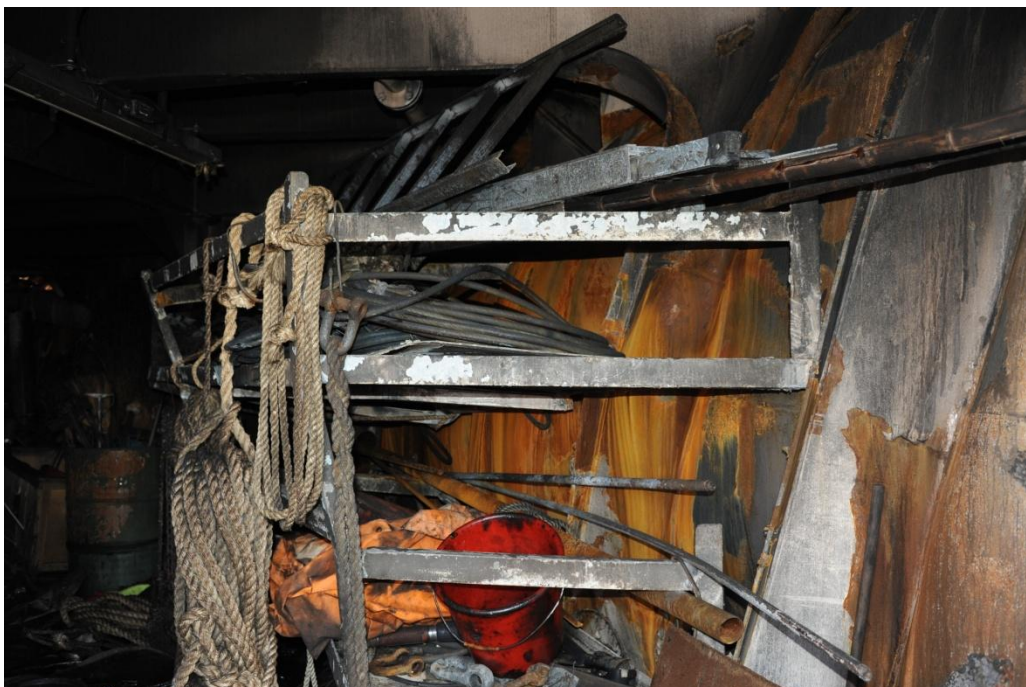
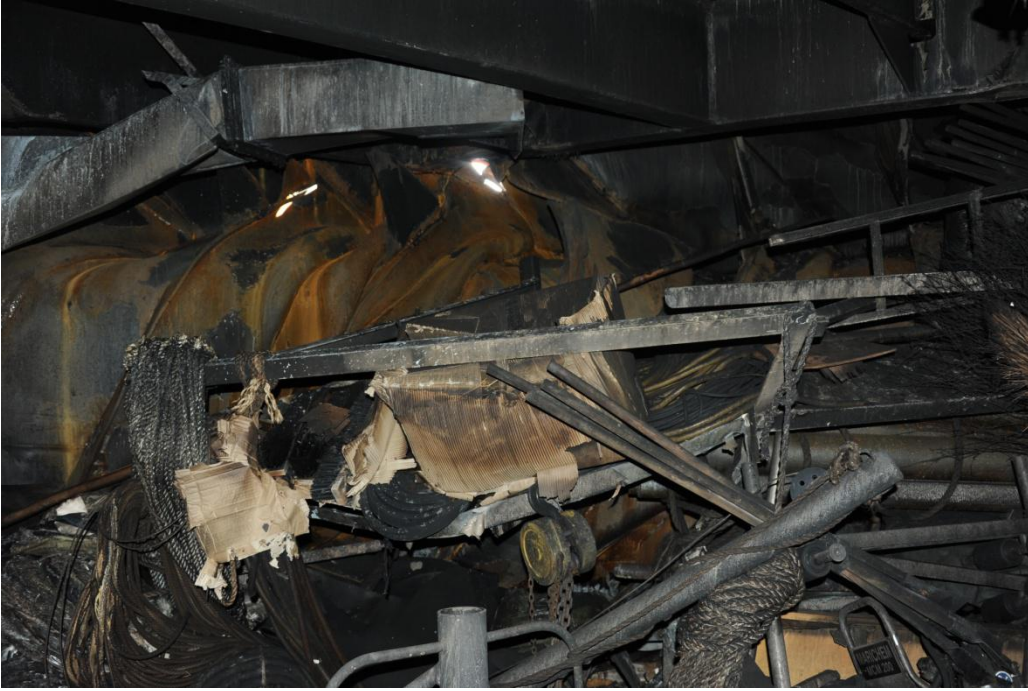
Starboard Forecastle Store

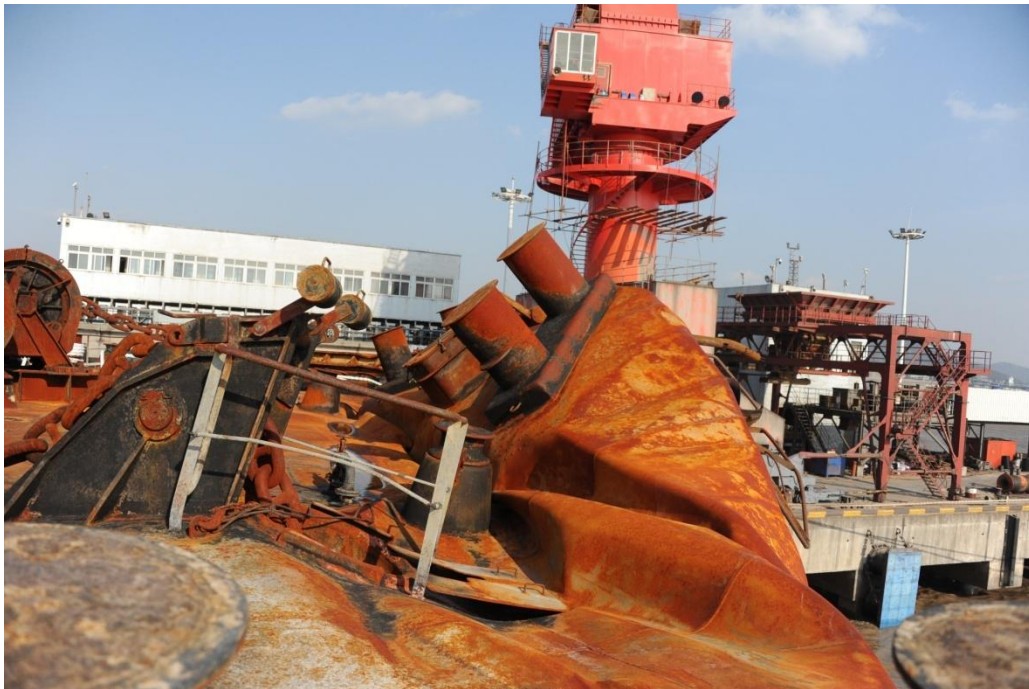
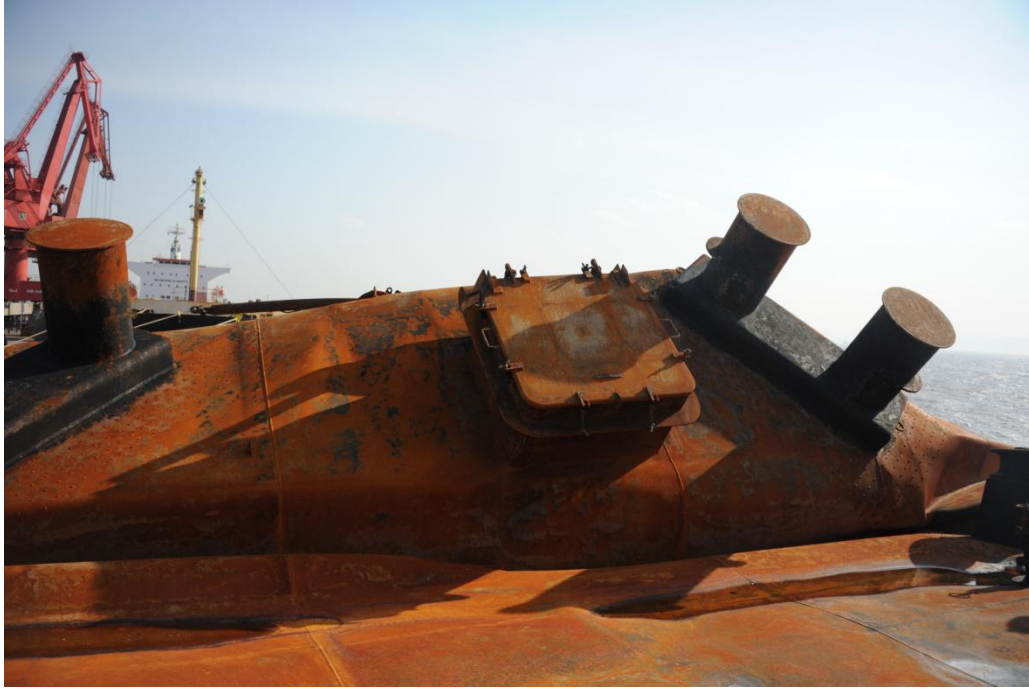
Forecastle deck bending backwards

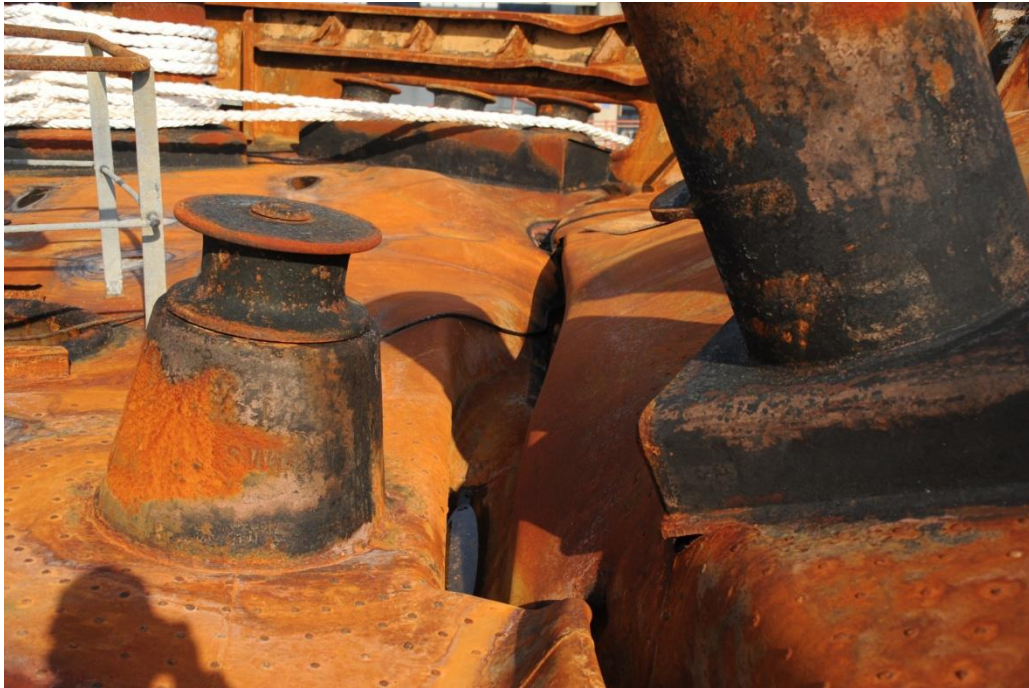
Fore-castle deck bending backwards

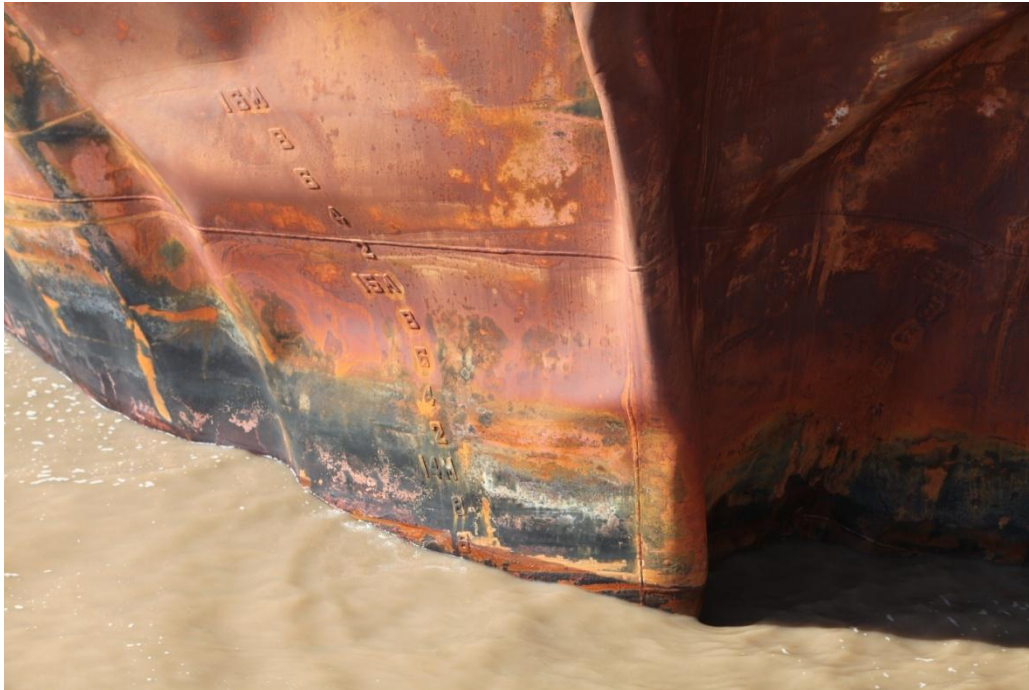
Foreward Starboard Draught 13.6 meters

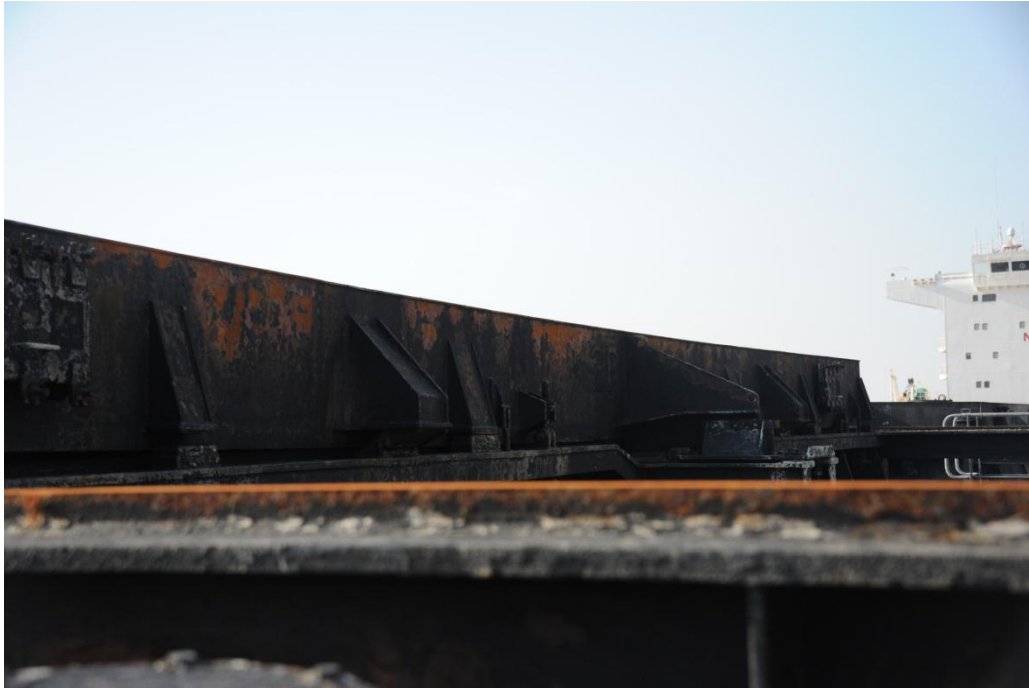
No. 1 Cargo Hold (sustained fire)

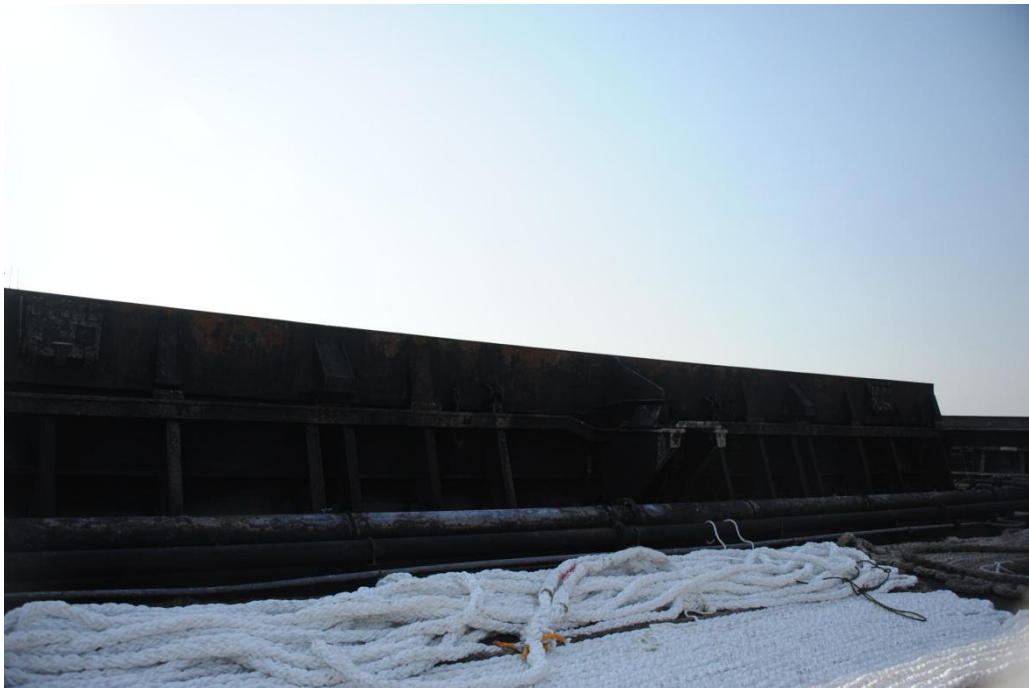
No. 2 Cargo Hold (sustained fire)

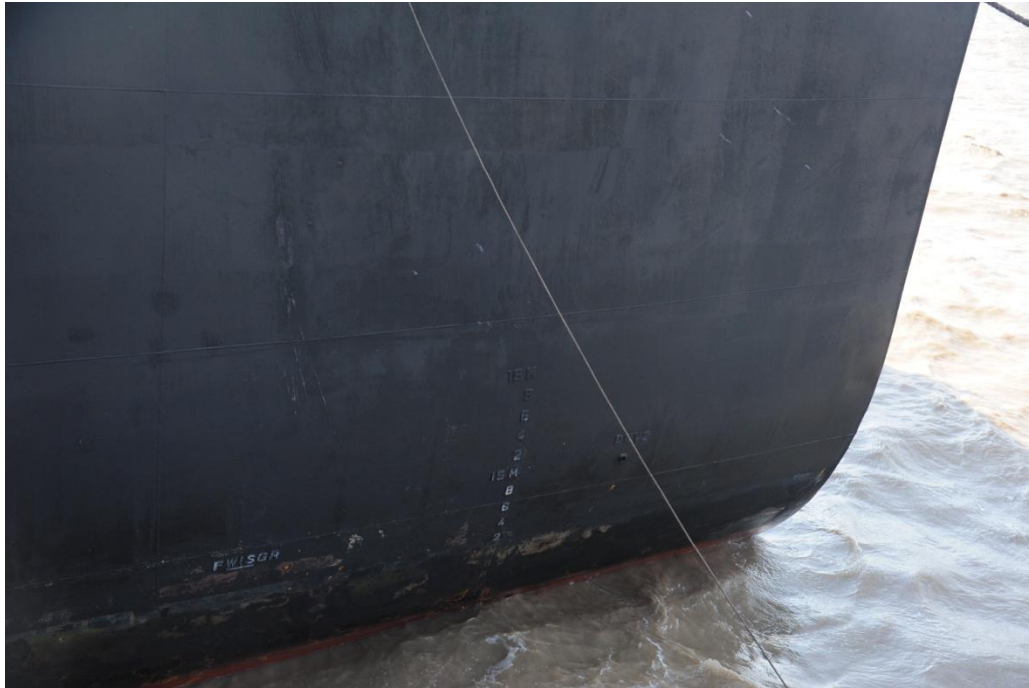
Aft draught 13.2 meters

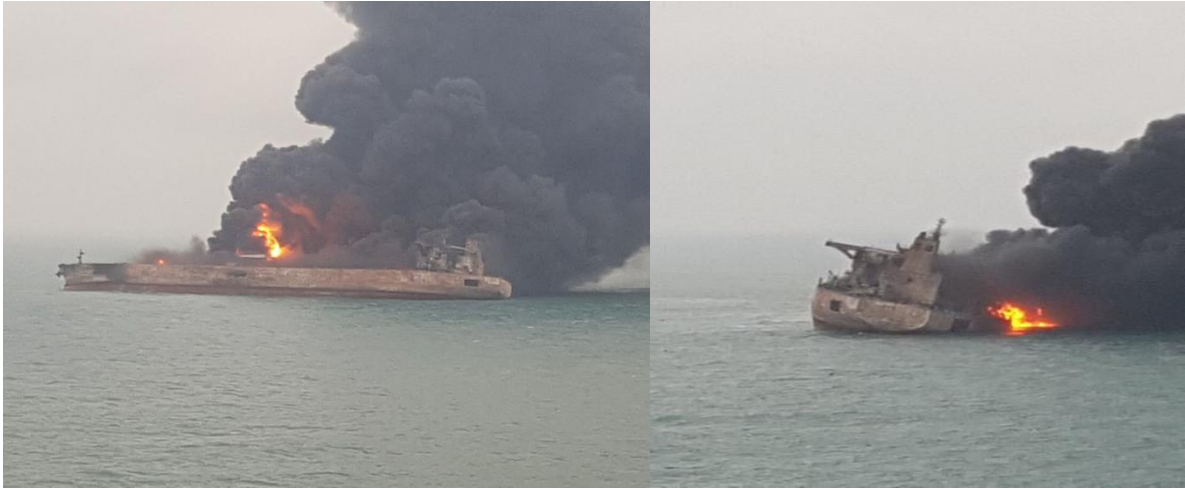
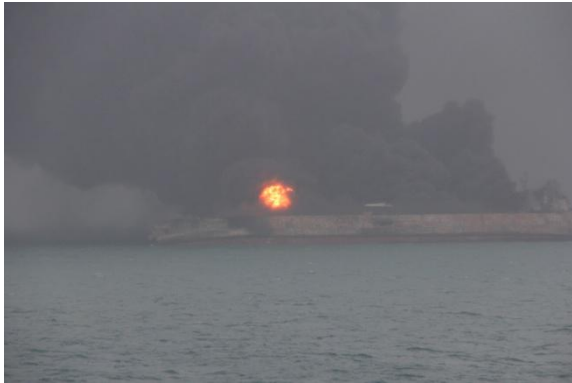
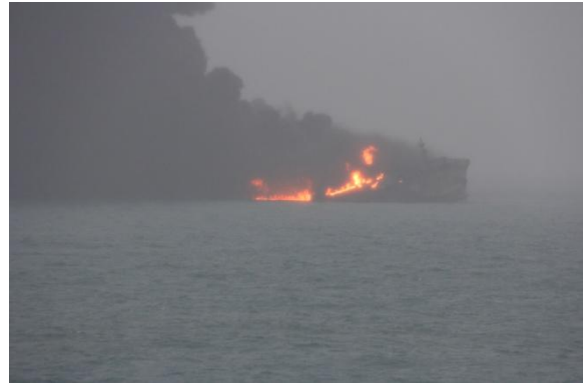
SANCHI on Fire and Vessel listing to Starboard

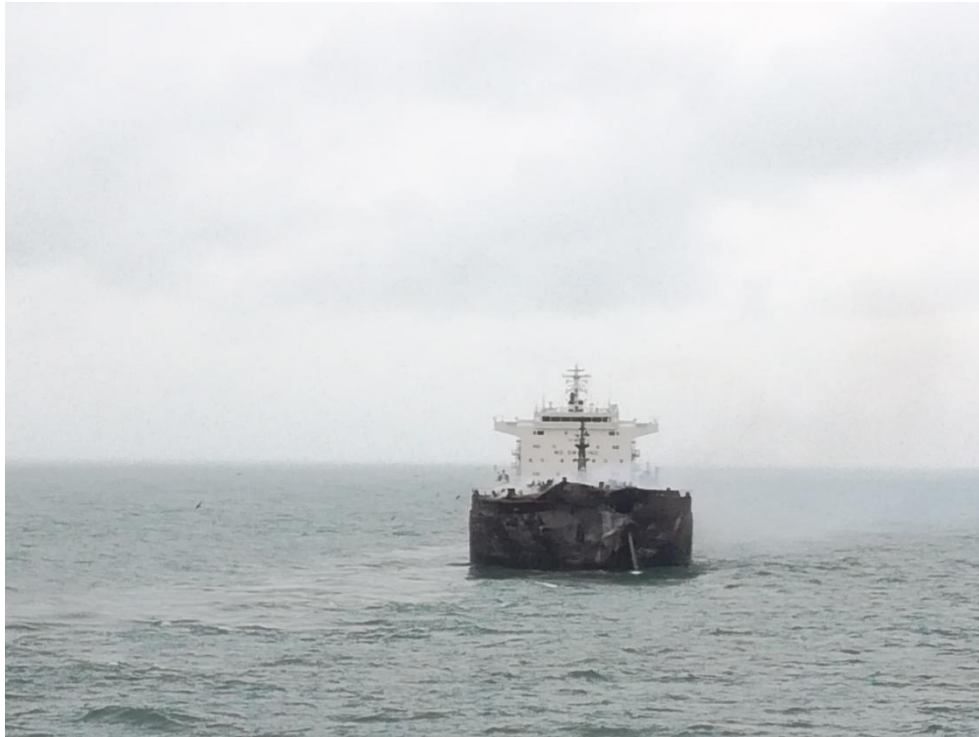
CF CRYSTAL's condition after abandoned

Front View

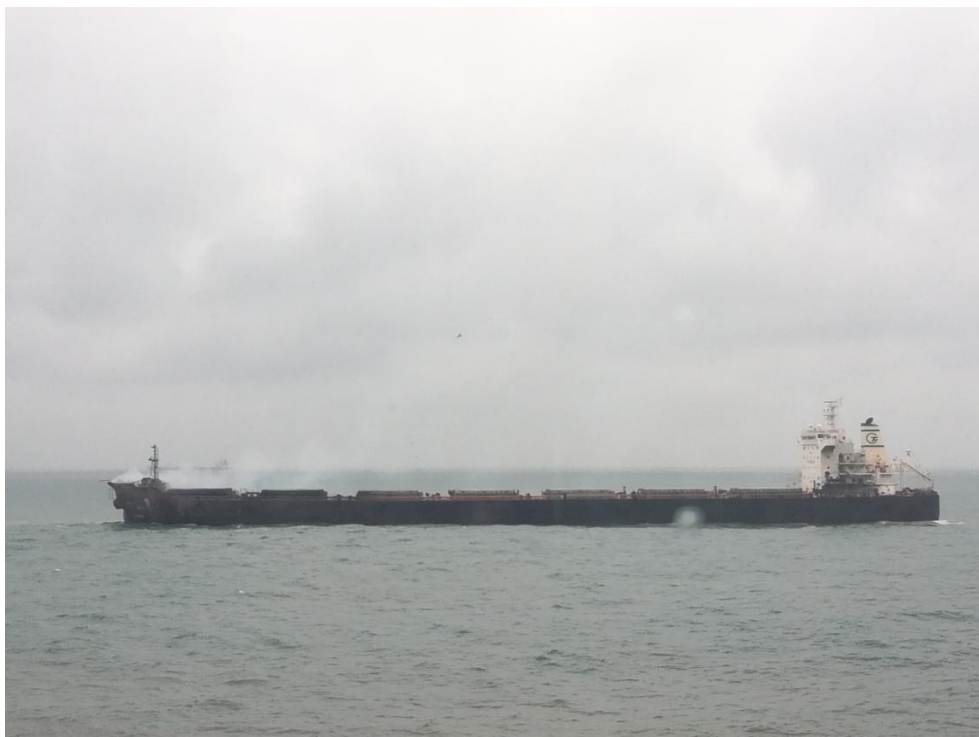
Starboard View

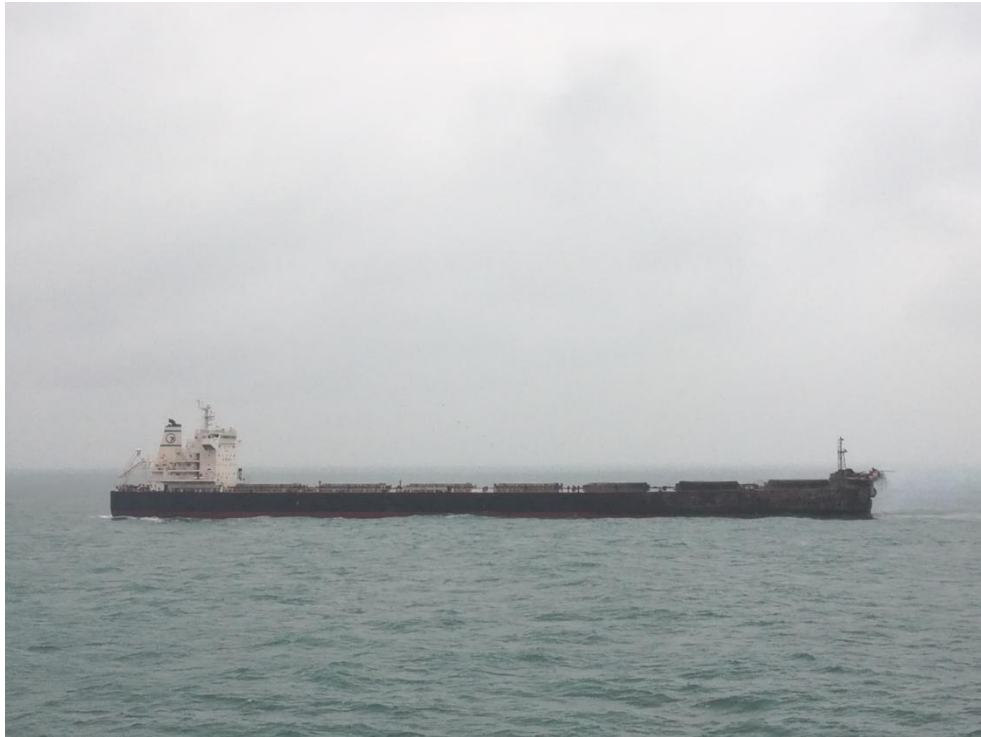
Port Side View

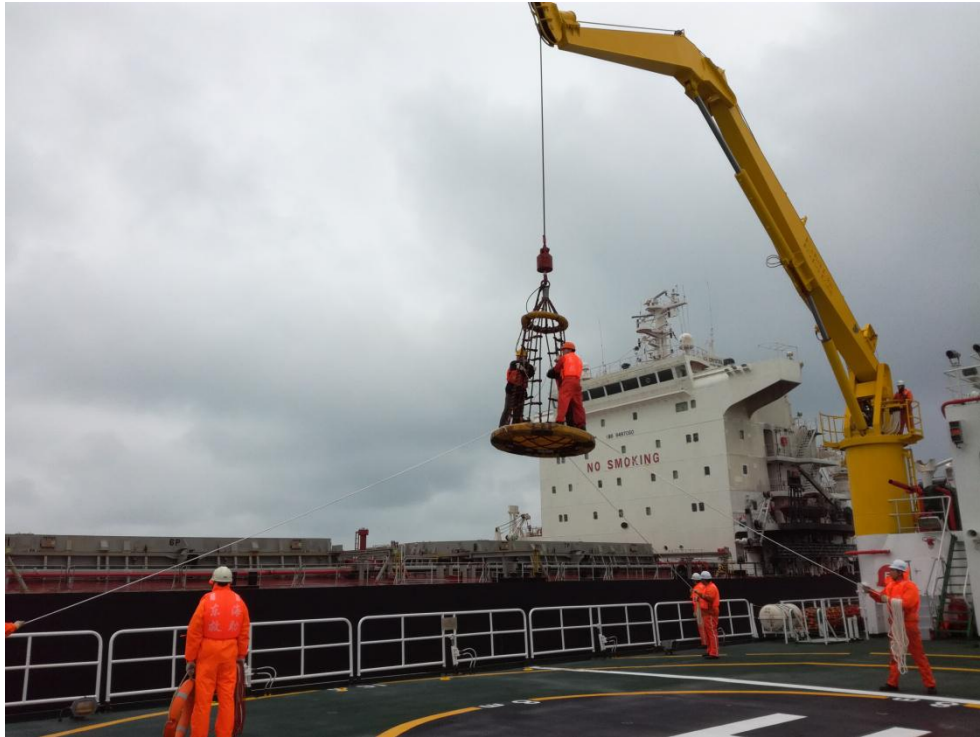
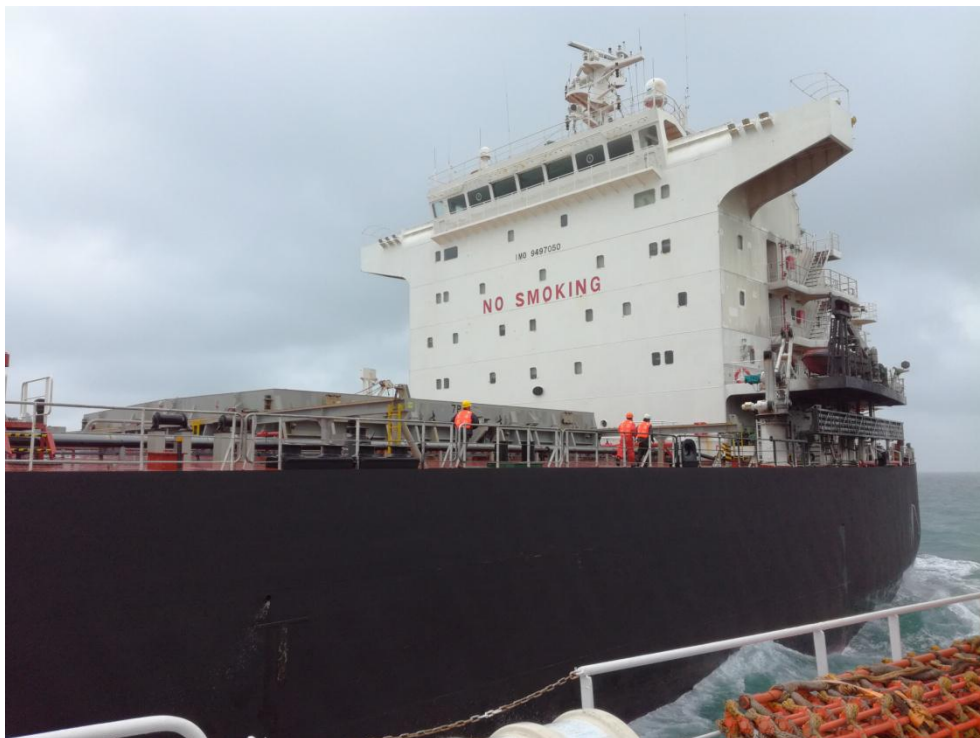
The CF CRYSTAL's crew were sent back by DONGHAIJIU 101.

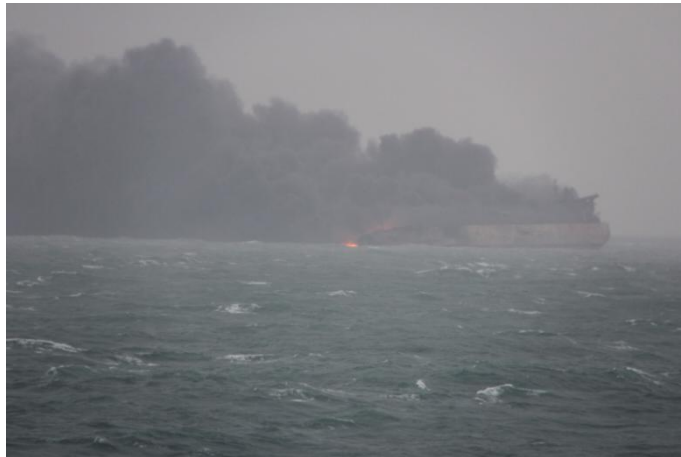
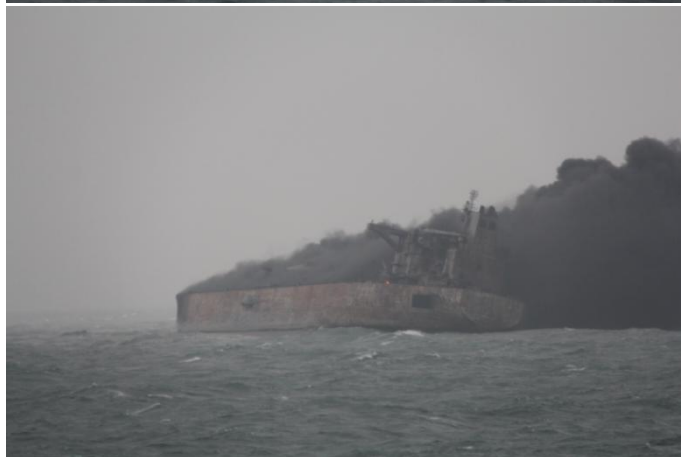
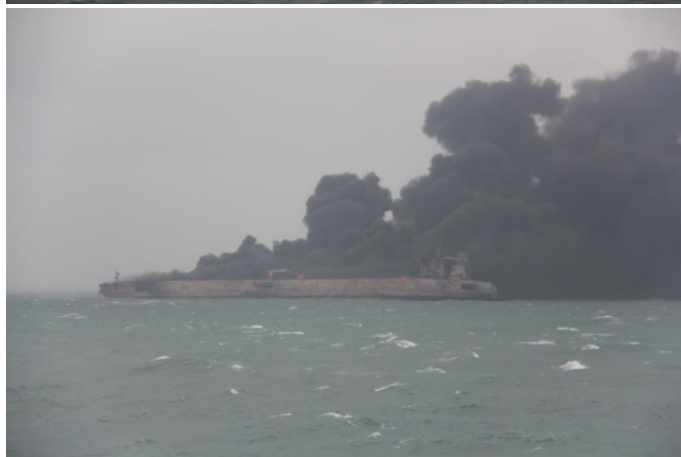
SANCHI on Fire

Fire continued and spread to stern. One body of SANCHI's crew was found and recovered from water by DONGHAIJIU 117.

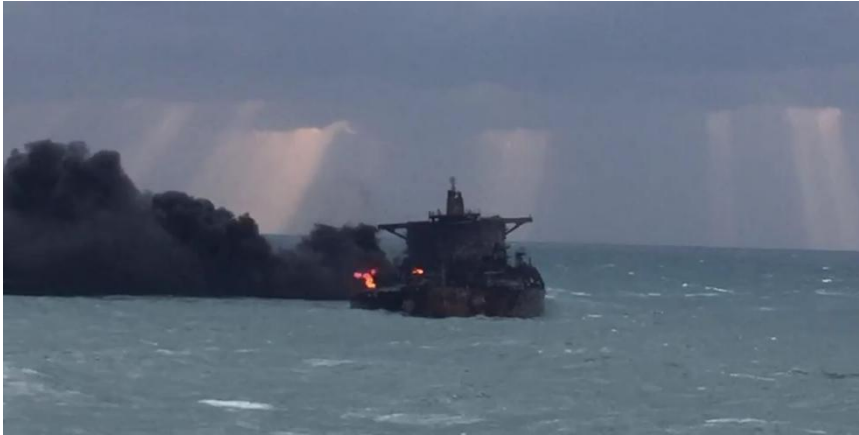
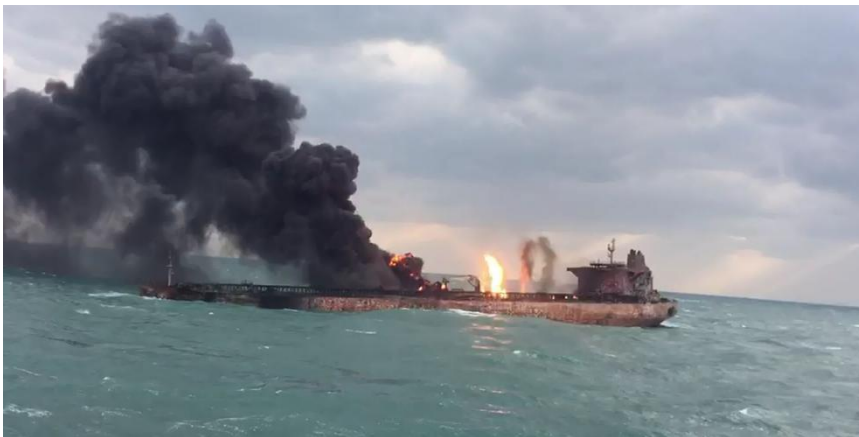
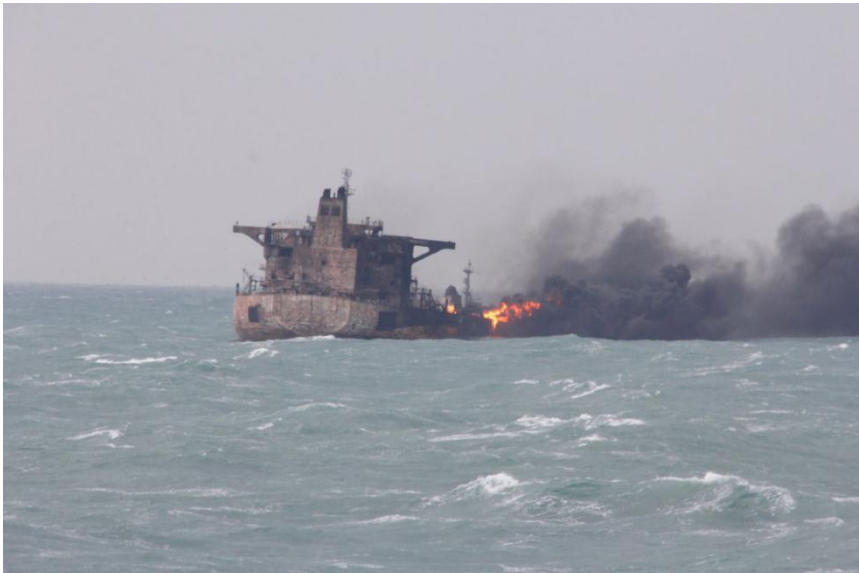
SANCHI on Fire

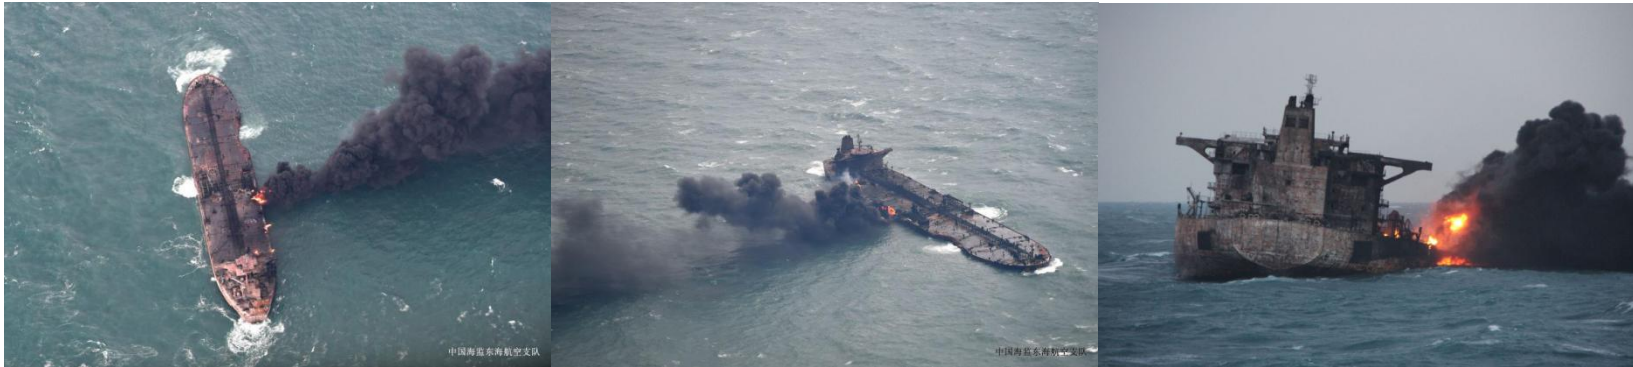
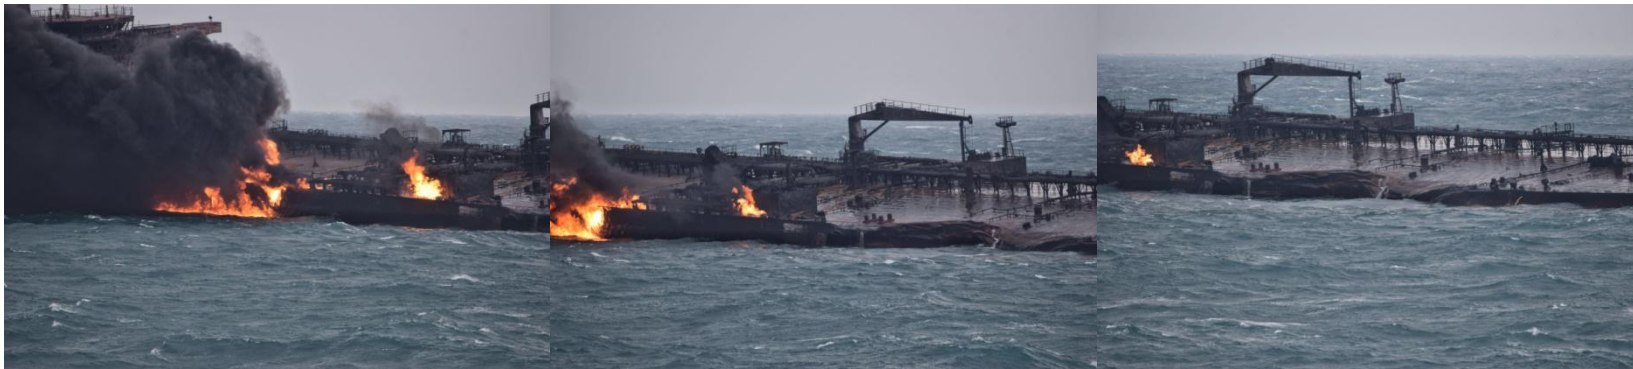
Fire mainly in rear of starboard midship, and the ship listed to starboard and trimmed by head.

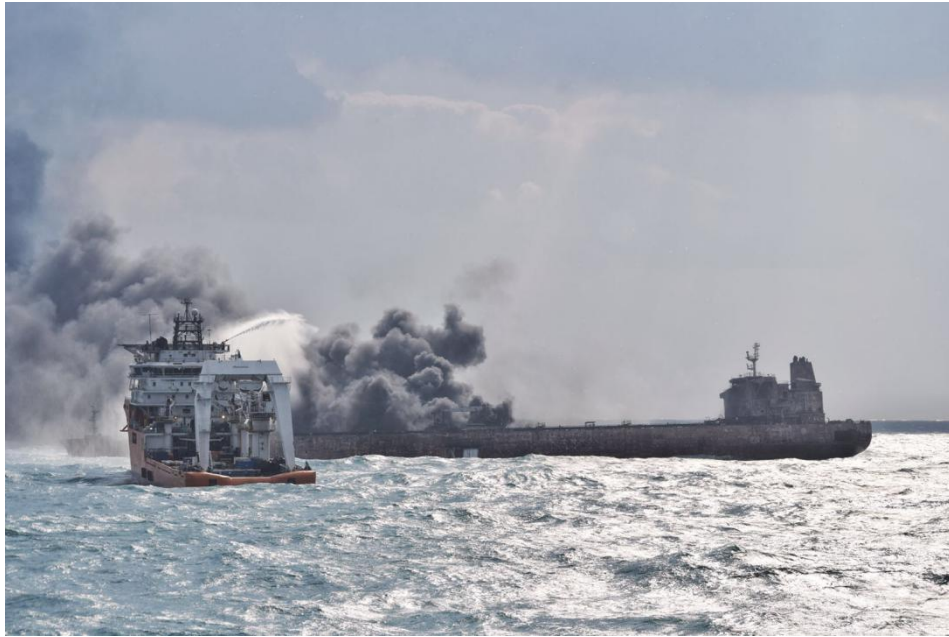
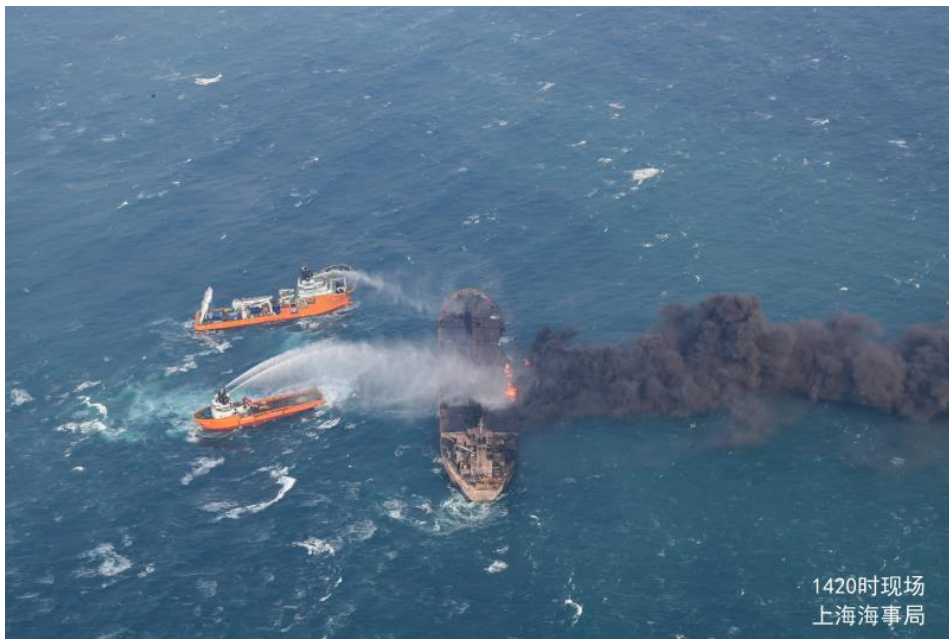
Rescue vessels on site went on firefighting.

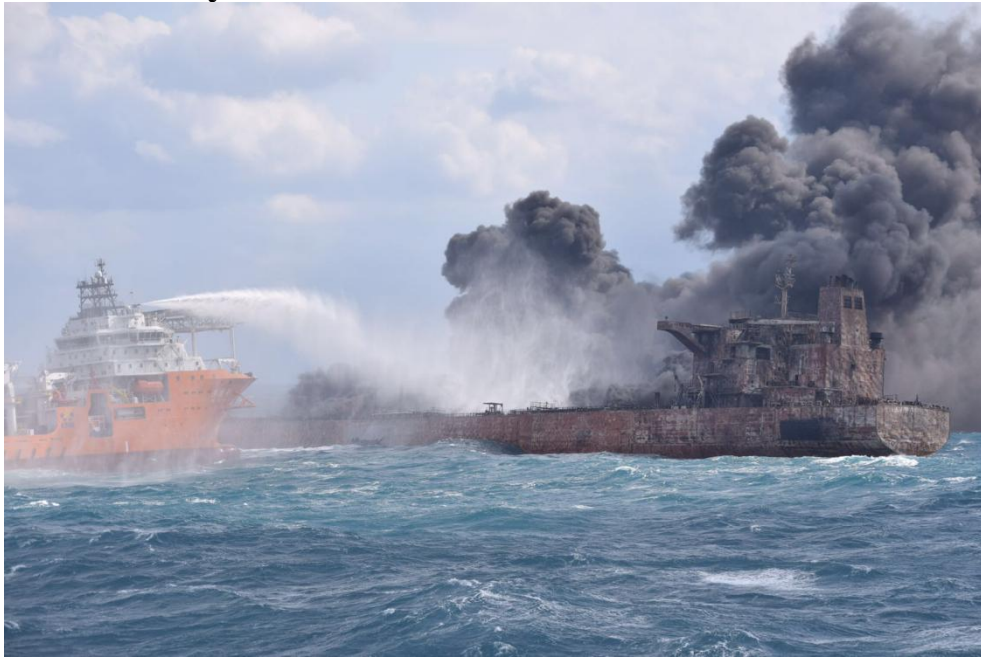
Firefighting by SHENQIAN and DONGHAIJIU 117

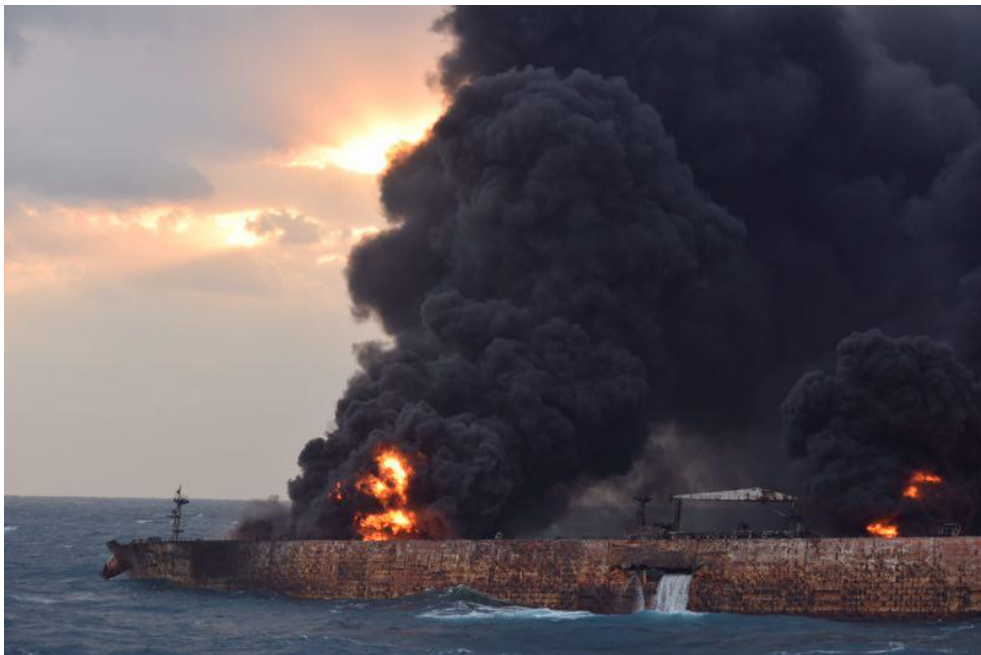
Explosive fire broke out again

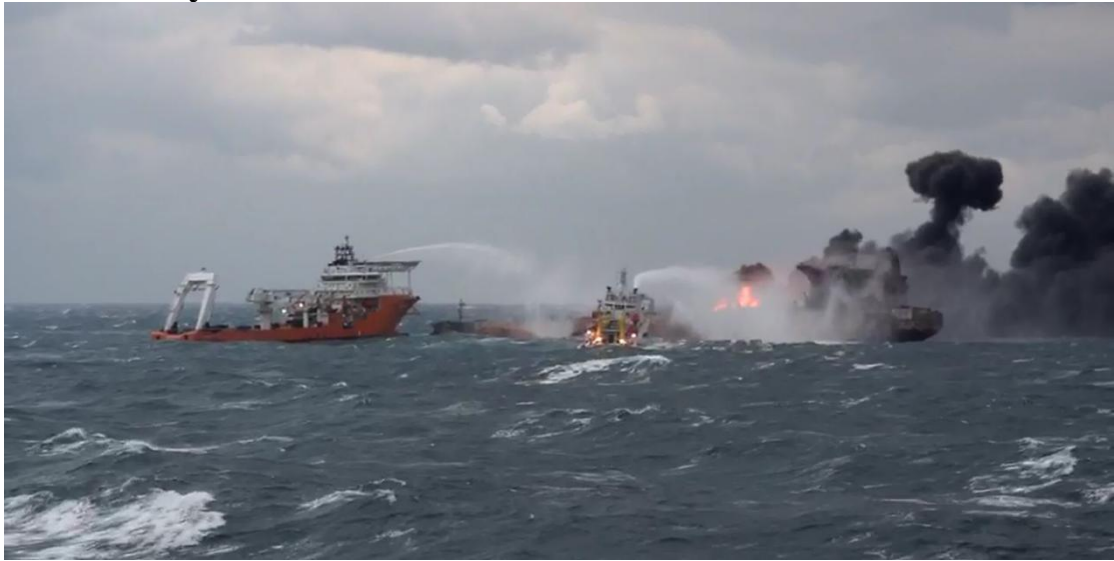
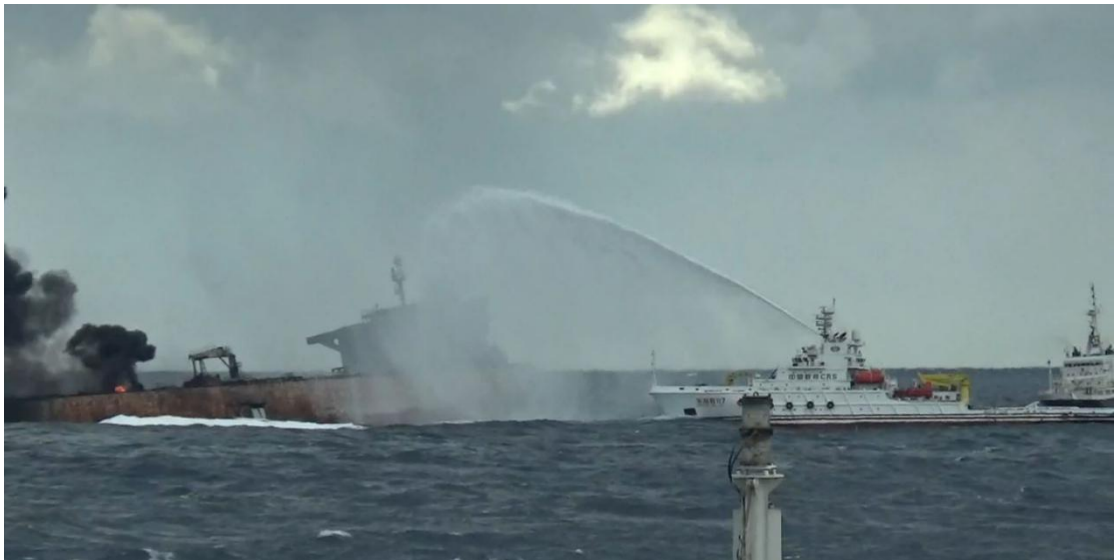
Rescue vessels on site went on firefighting.

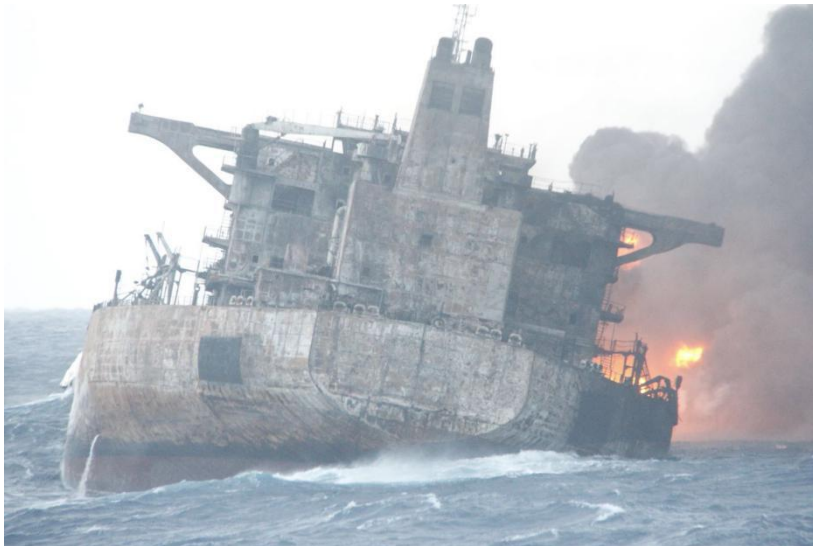
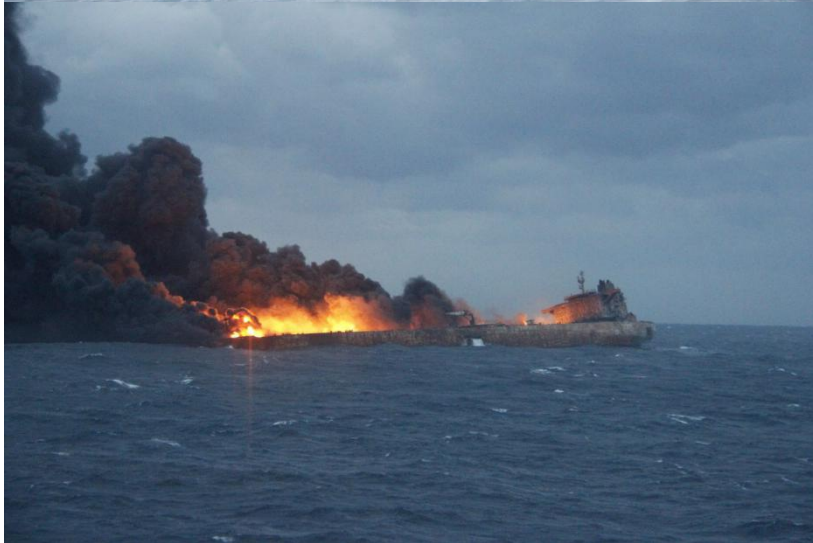
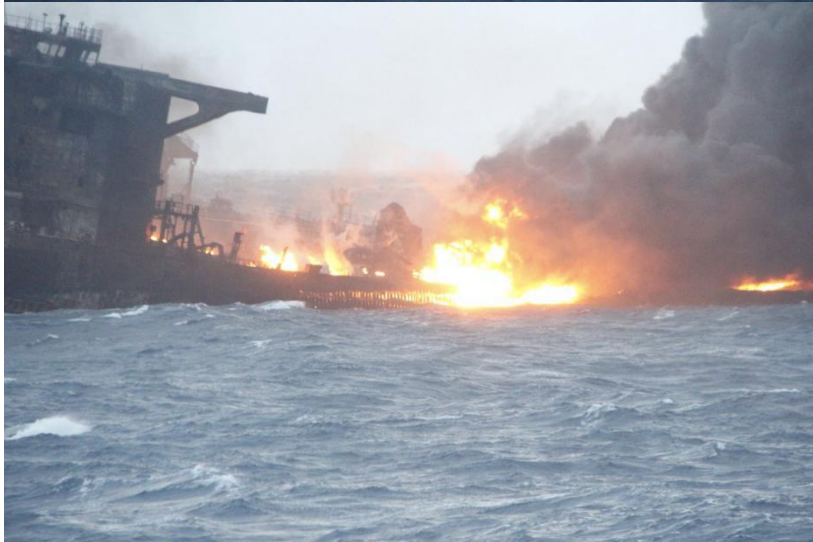
SANCHI still listed to the starboard with intensive fire
