Report on the Investigation of the Collision between
M.T. SANCHI
and
M.V. CF CRYSTAL
in East China Sea
on 6 January 2018

Very Serious Marine Casualty
10 May 2018

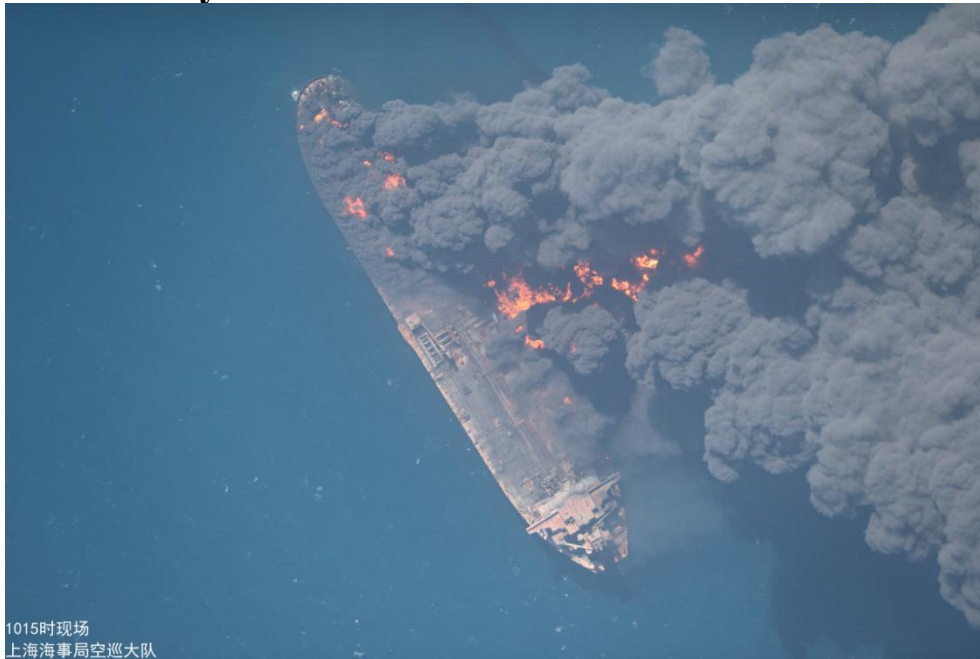
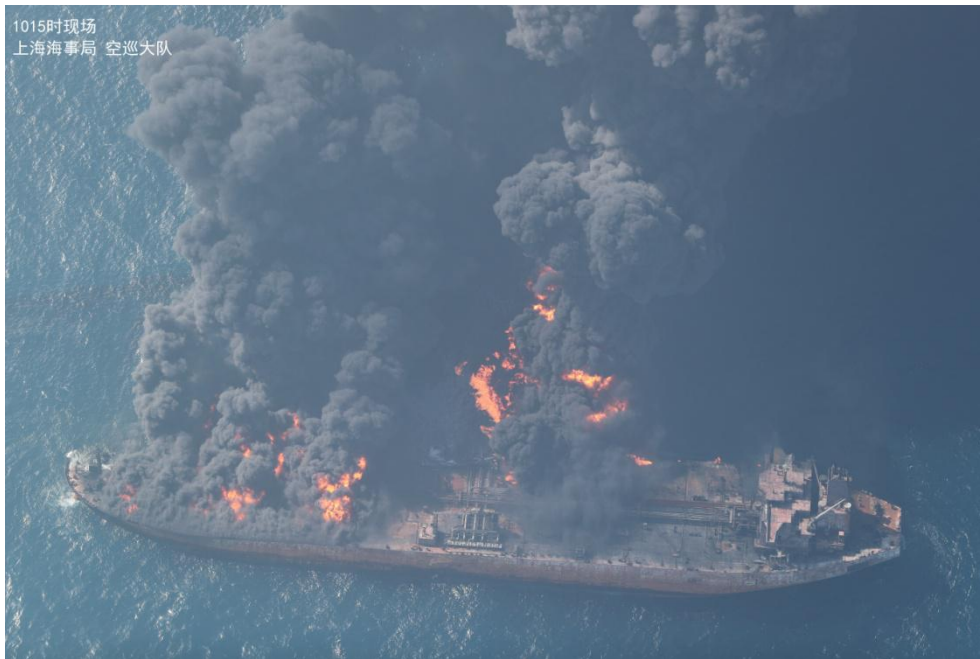
SANCHI on fire

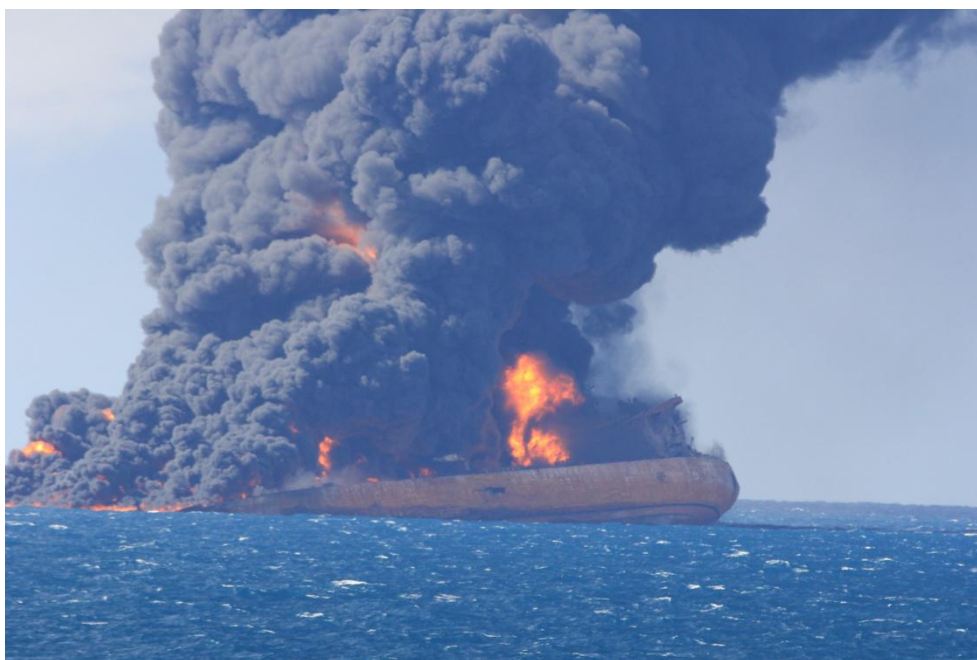
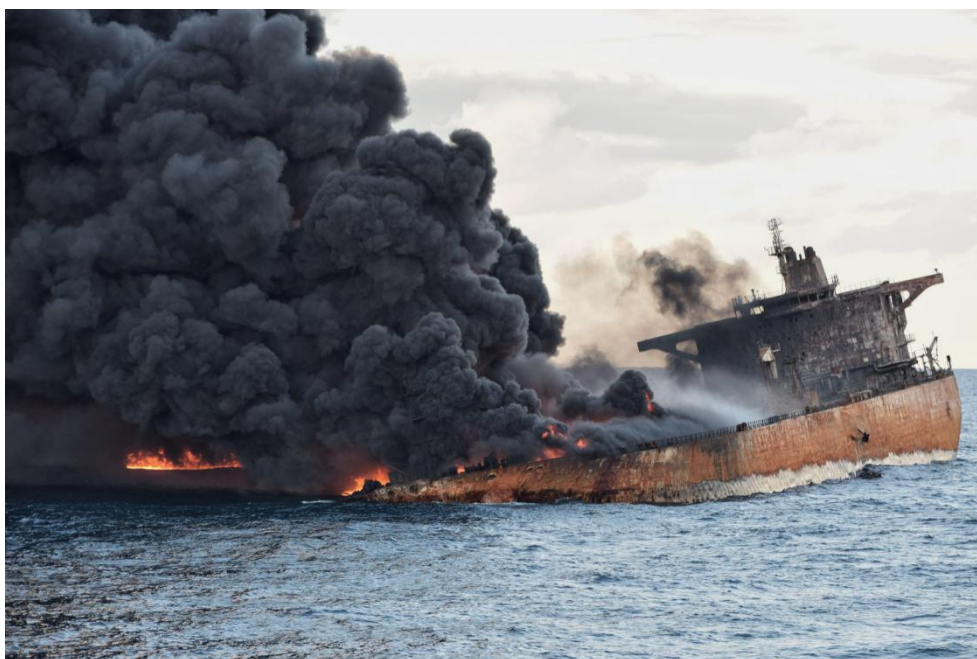
The bow of SANCHI submerged into water.

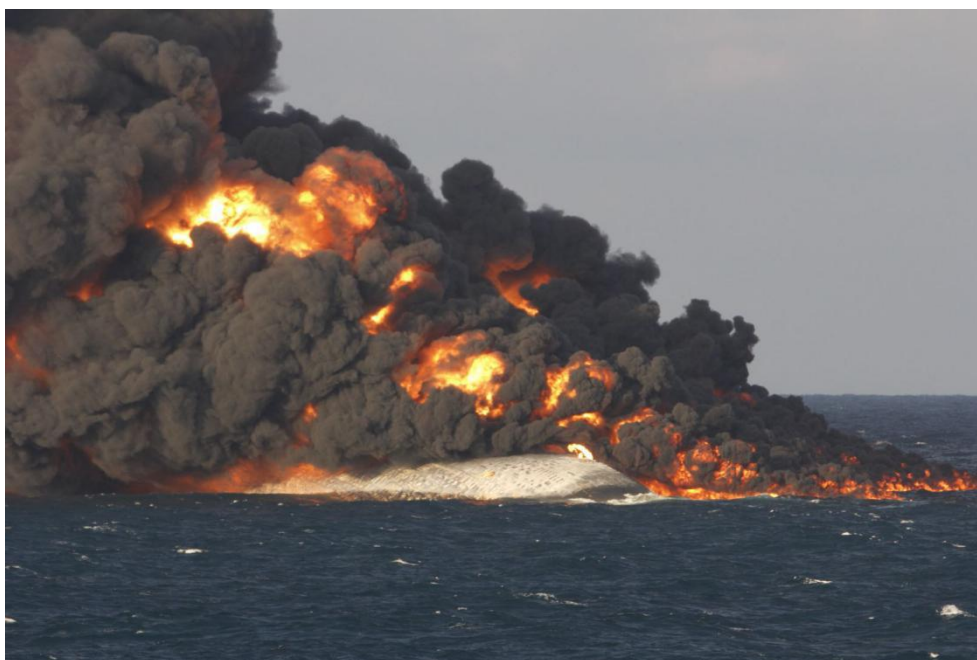
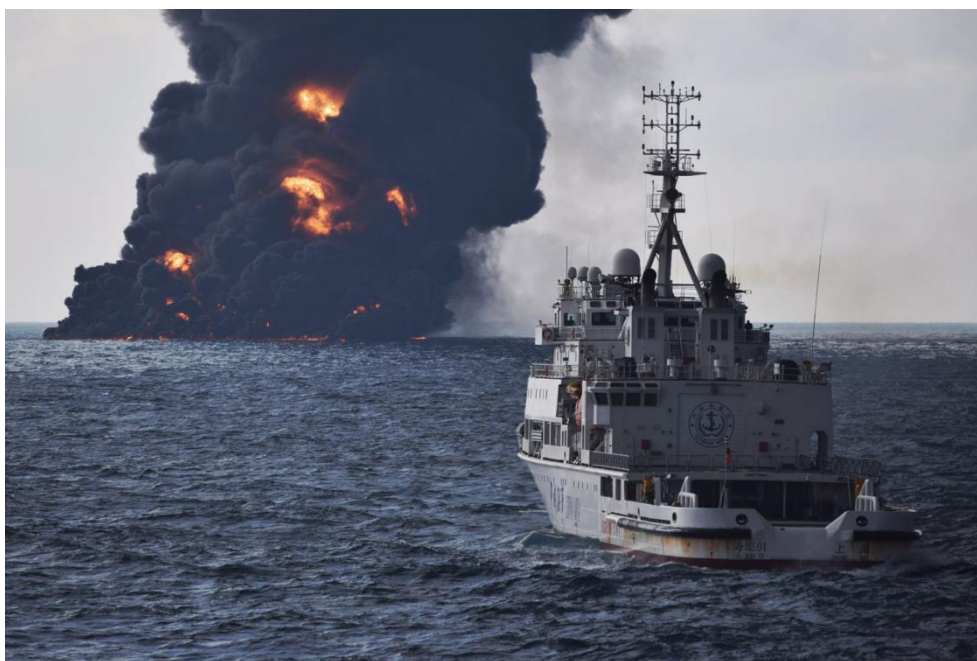
Vessel listed to starboard by about 90 degrees with a small part of the hull out of the water.
